EUROPEAN ROOFER'S EXPERIENCE AFTER THE 100 MPH WINDS OF JANUARY AND FEBRUARY 1990

BERT MASSAUT

Roofing Contractor
Gravenhage, Holland

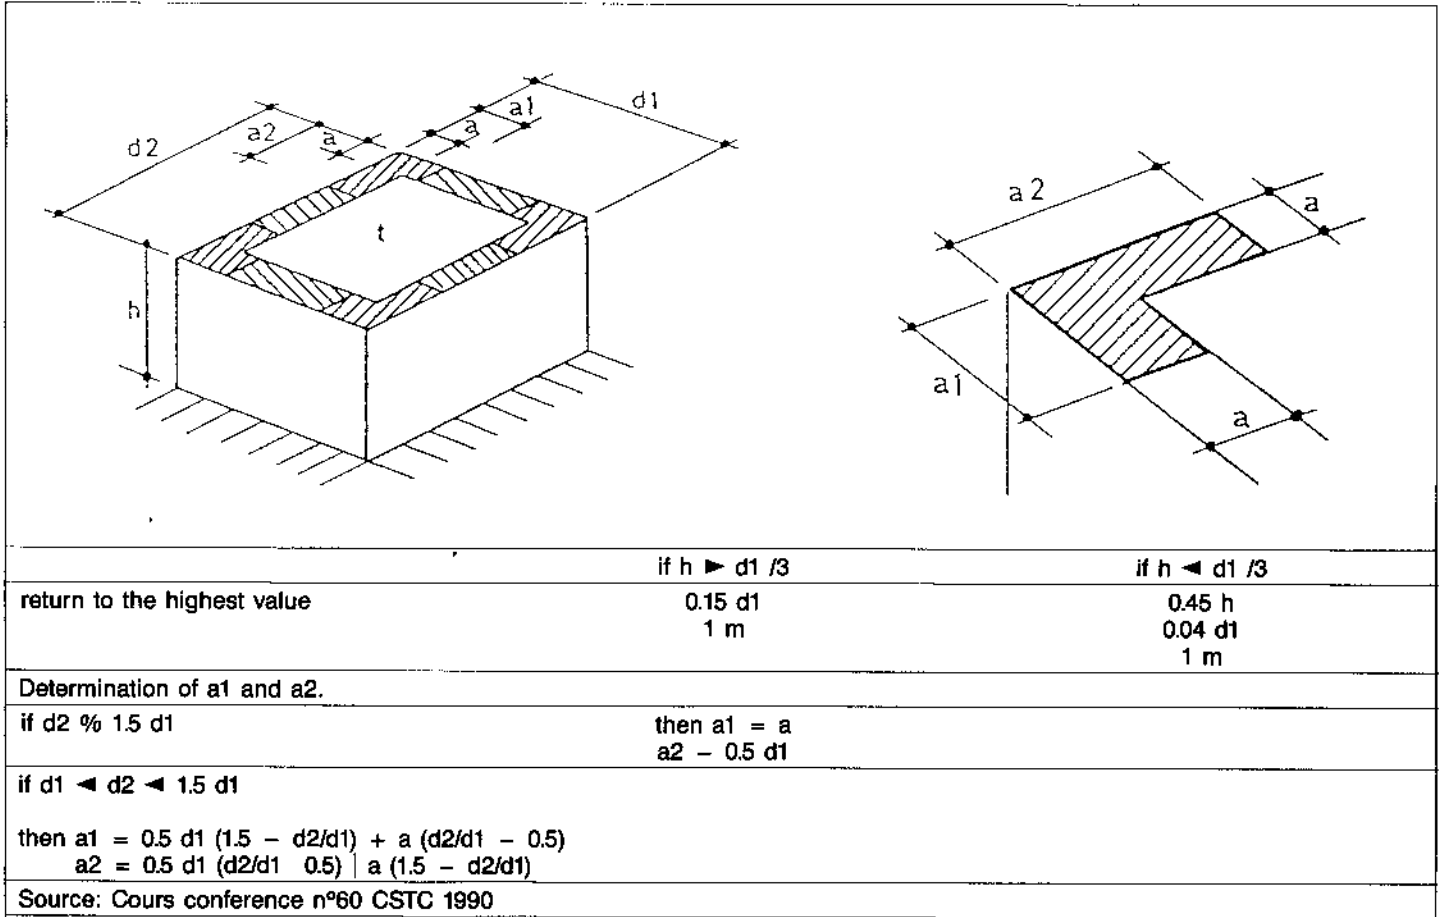
Figure 4 Determination of the width of the edge areas a.

The new standard explains how to determine the edge and corner area of the roof. Parapets and metal coping must pass the criteria set for the corner areas (see Figure 4).
