# DEGRADATION OF FIRE-RETARDANT-TREATED PLYWOOD: CURRENT THEORIES AND APPROACHES

**MARY ROSE STILL**

**SUSAN L. LeVAN**

**JOSEPH D. SHUFFLETON**

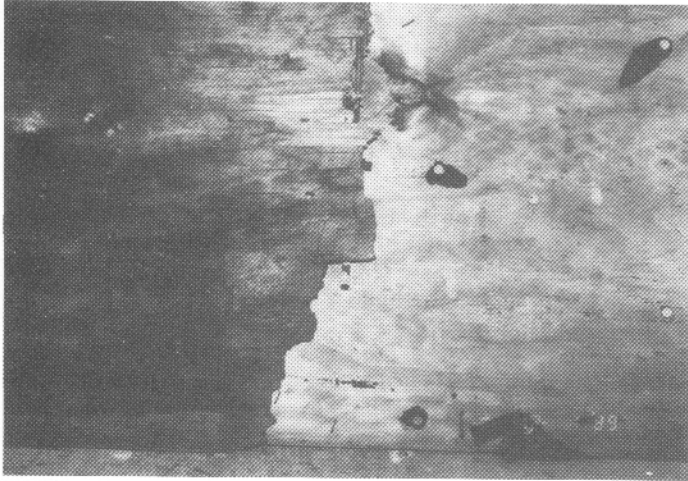
Deterioration of the FRT plywood is visually recognizable. Interior views of attic spaces have confirmed that the underside of the wood darkens significantly (see Figure 1). A characteristic dark, reddish-brown, charred appearance is often evident. Although quite similar to the visual characteristics of rot, tests have confirmed that no fungi are present. Such discoloration is even more apparent on the top side of the FRT roof sheathing which is covered by the roof shingles. This darkening is often accompanied by localized white staining caused by the accumulation of fire-retardant chemicals, such as salts.

Figure 1 Comparison of FRT plywood vs. untreated plywood.

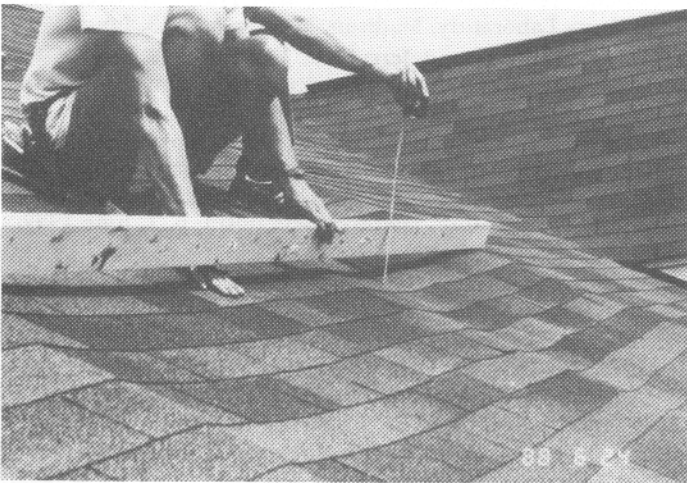
Severe deck deflections (warpage) are often apparent within a few months of installation (see Figure 2). The roof may sag, appear uneven and actually buckle in waves. Physically, the wood appears brittle and delaminated. It may become brash and crumbly, and can crack or shear when stressed. Audible cracking (which has been likened by fire department officials to "walking on potato chips") is often apparent under foot traffic.

Figure 2 Excessive deflection of FRT plywood decking.
