# DAMAGE TO MEMBRANE ROOF SYSTEMS CAUSED BY THE 1995 HYOUGOKEN-NANBU EARTHQUAKE

KYOJI TANAKA

ICHIRO SHIMIZU

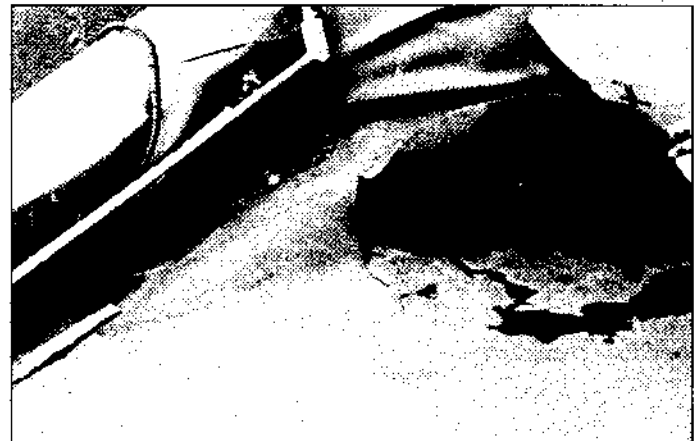
Photograph 1.

Photograph 1 shows the roof deck of a reinforced concrete apartment building with a L-shaped plan. The mechanically fastened PVC membrane was torn by the collapse of the deck at the corner of the L-shaped plan.

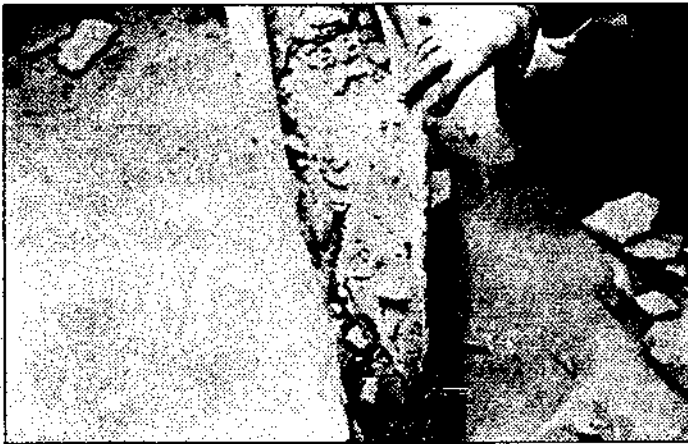
Photograph 3.

Photograph 3 depicts the rupture of a fluid-applied membrane on mortar screed on cement chip boards that were fixed on a steel structure. A long split occurred along the crack of mortar screed.

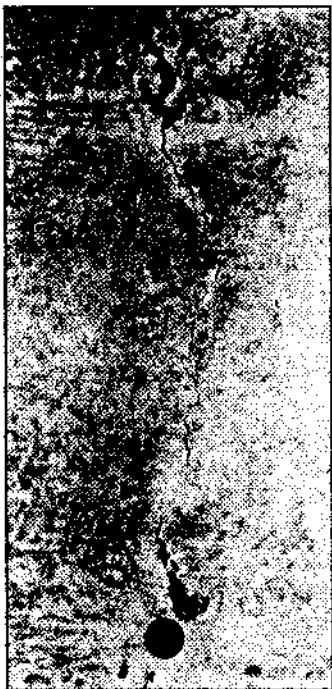
Photograph 4.

Photograph 4 shows a glass-fiber-reinforced unsaturated

polyester resin membrane that was split by the cracking of a reinforced concrete deck. Although the membrane had extremely high mechanical strength compared to the other membranes, it was not able to withstand severe movement.

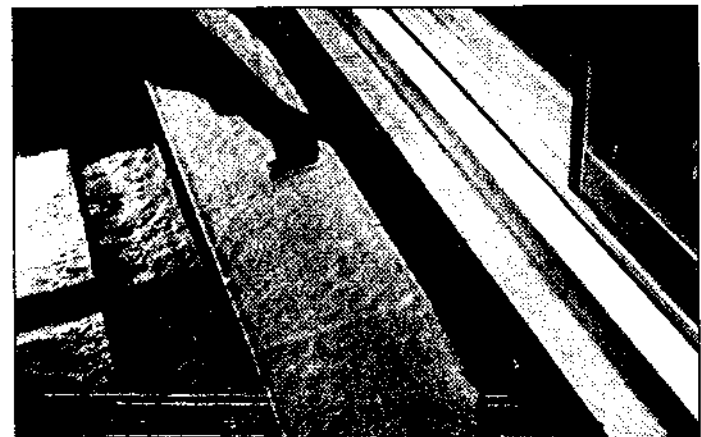
Photograph 7.

Photograph 7 depicts a glass-fiber-reinforced unsaturated polyester resin membrane that completely separated from the mounted wall of sliding doors. Opening was observed along the end of the membrane.

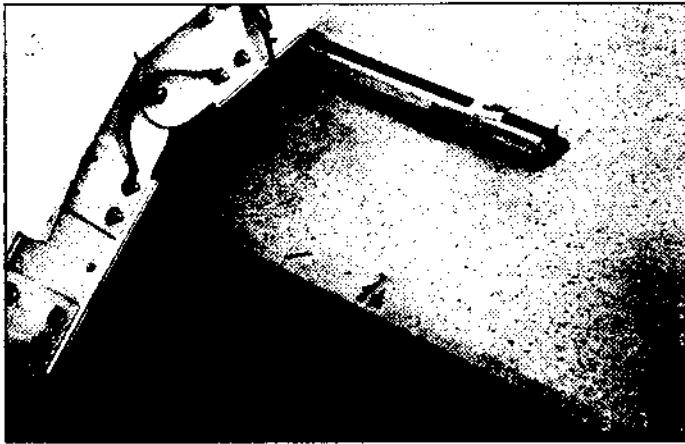
Photograph 8.

Photograph 8 shows a piece of equipment that fell onto a PVC membrane and punctured it.

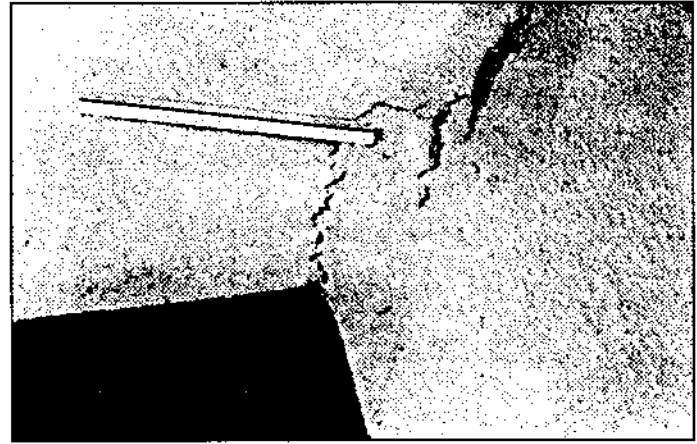
Photograph 11.

Photograph 11 shows a fluid-applied membrane coated on a cement mortar coping; the membrane ruptured at the corner of the coping.

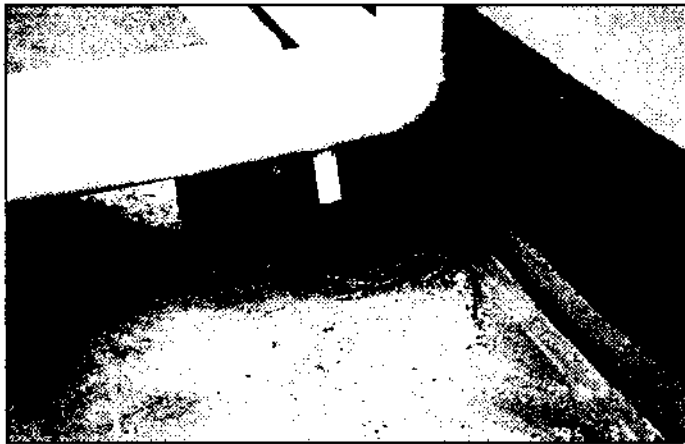
Photograph 9.

Photograph 9 shows a small base for a service pipe that slid and ruptured a polyurethane rubber fluid-applied membrane.

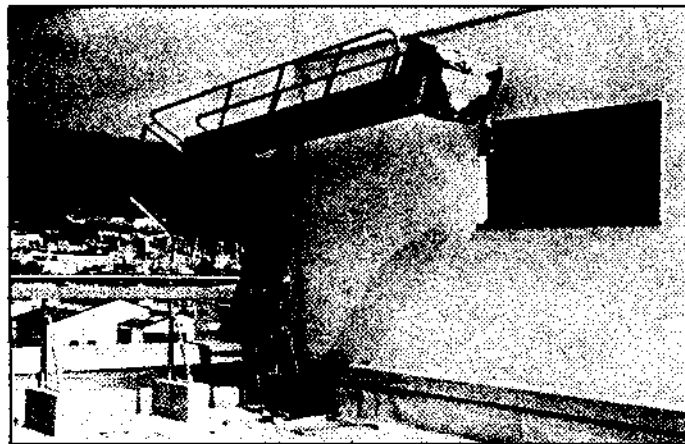
Photograph 10.

Photograph 10 shows a warehouse with a crane structure. The leaning of the crane tower lifted a stepstone to the tower, tearing off the EPDM sheet membrane covering the stepstone. The damage may have been avoided if the membrane had been laid beneath the stepstone.

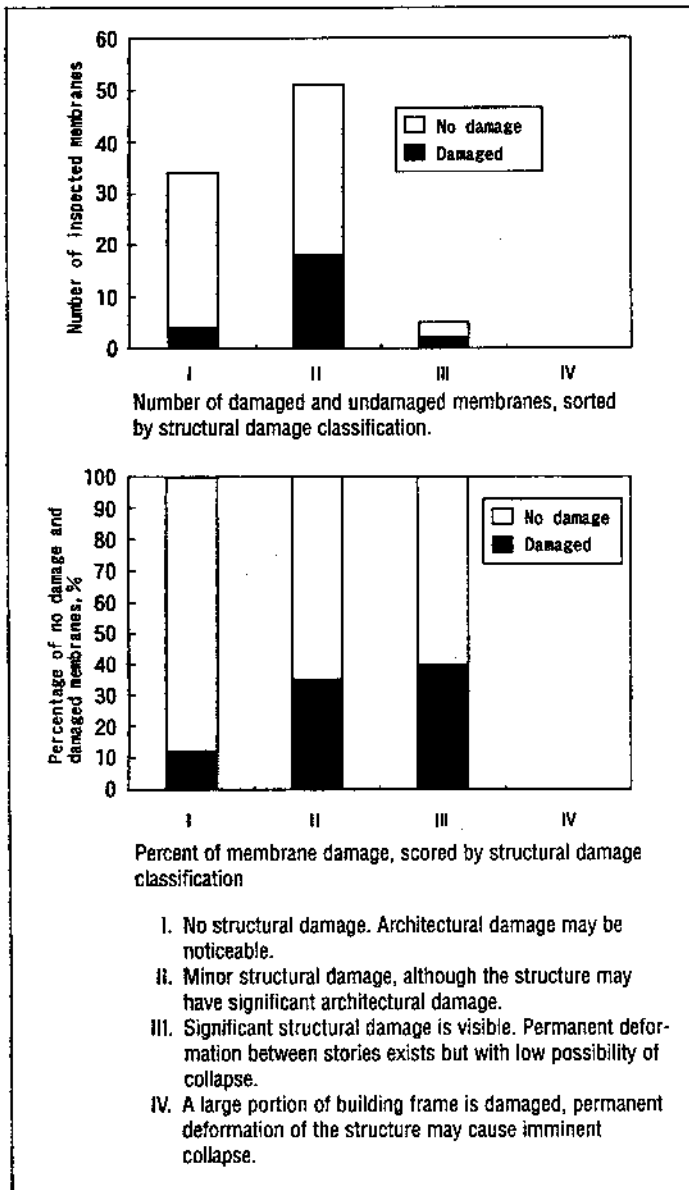
The upper portion of Figure 4 shows a number of damaged membranes sorted by the level of structural damage; the lower portion shows them as percentages. It is quite natural that the ratio of damaged membranes increases as structural damage level becomes more severe. However, there are many membranes that were not damaged, though their columns, beams, and walls were damaged. This is because the hori-

zontal members, such as roof decks, were shaken as a whole during the earthquake in most buildings. The result was that the horizontal members were not severely deformed and ruptured compared to vertical elements.

Figure 4. Relation between damage of membrane and damage level of structure.

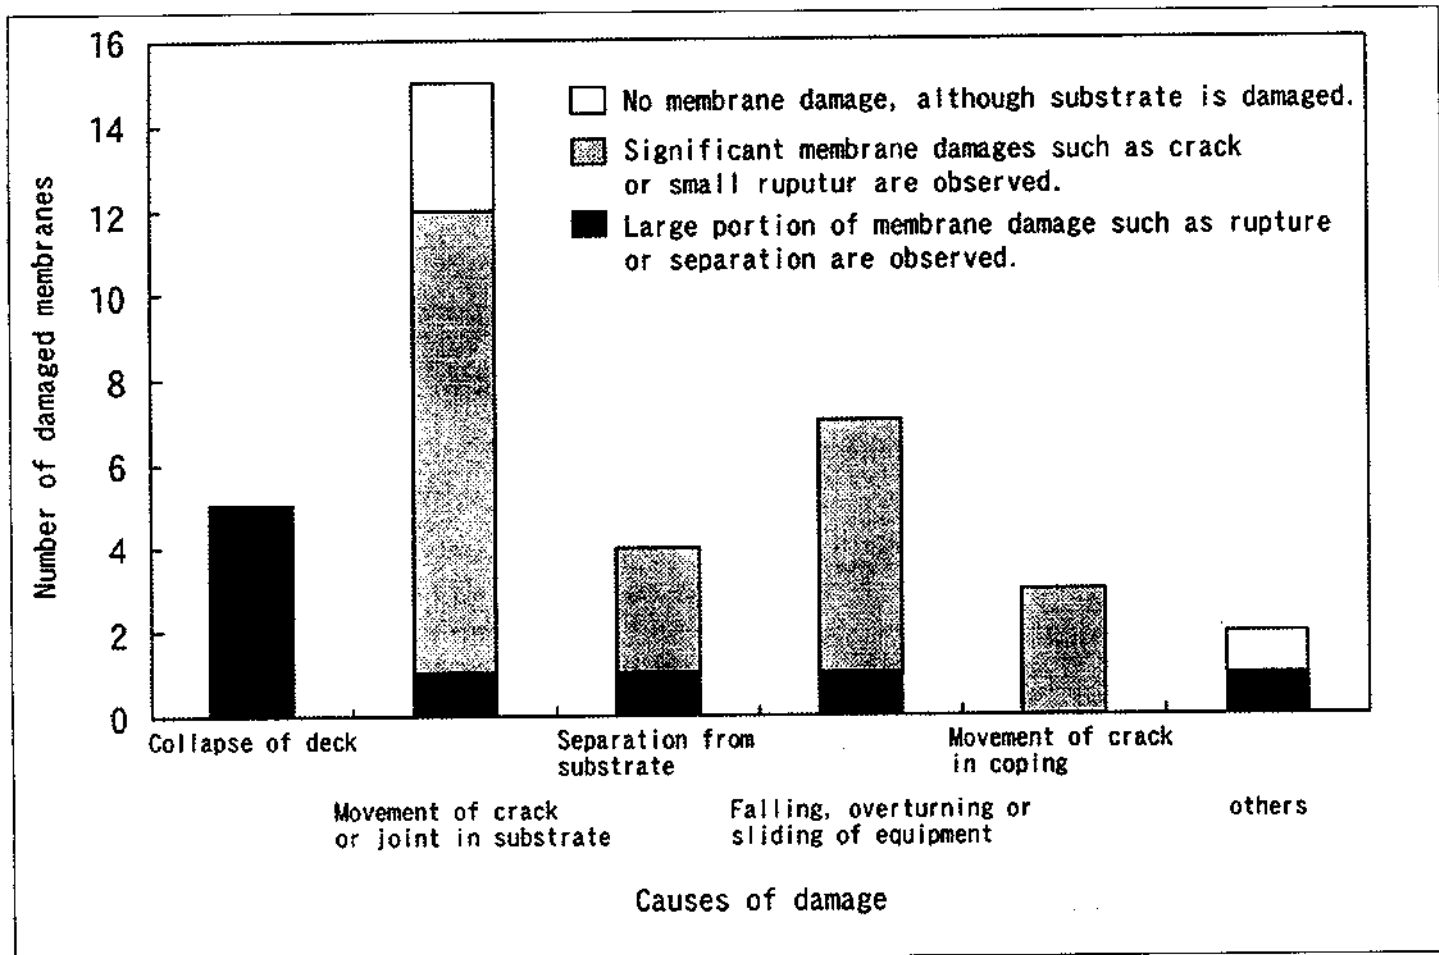
Figure 5 shows the type and level of membrane damage. Severe damage was observed only in the membranes of collapsed decks. The possibility of a large joint movement, as occurred in the earthquake, was not taken into consideration during the design of the membrane roof systems. Therefore, the damage seemed quite reasonable considering the movement capability of the existing membrane roof systems. The earthquake clarified how limited current membrane roof systems are in terms of movement capability.

Figure 5. Type and level of damages of membranes.

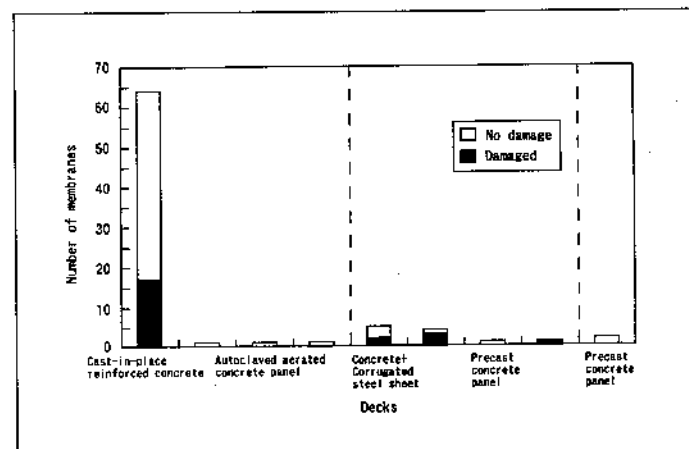
Figure 6 shows the number of membrane failures for each type of structure and deck. The number of membrane damages is prominent in reinforced concrete frame structures, because more than 80 percent of the inspected membranes were applied to these structures. However, the ratio to total number of damages is reduced to about 0.3, because there are a lot of the structures that had undamaged membranes.

As for decks, damaged membranes were also prominent in cast-in-place reinforced concrete decks. However, the ratio to total number of damages also was not very high. The higher ratio is shown for precast panel decks, such as an autoclaved aerated concrete panel and a cement board, particularly in steel frame structures.

Although it could not be proven statistically, it seemed that the combination of precast panel decks fixed to a steel frame structure suffered damage more severe than any other combination of deck and structure.

Figure 6. Number of damaged membranes in each type of structure and deck.
