DAMAGE TO MEMBRANE ROOF SYSTEMS CAUSED BY THE 1995 HYOUGOKEN-NANBU EARTHQUAKE

KYOJI TANAKA

ICHIRO SHIMIZU

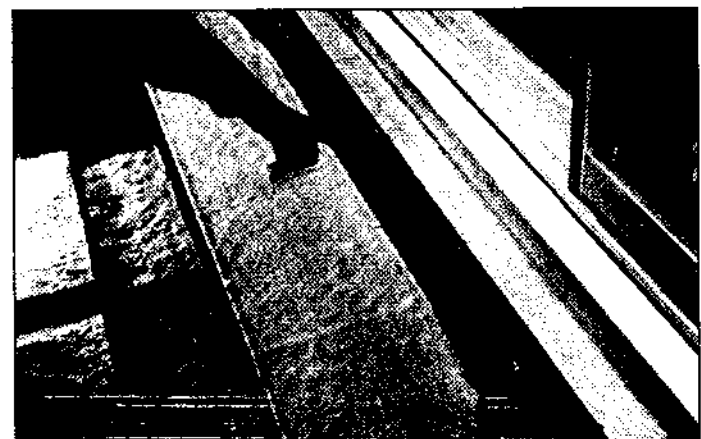
Photograph 7.

Photograph 7 depicts a glass-fiber-reinforced unsaturated polyester resin membrane that completely separated from the mounted wall of sliding doors. Opening was observed along the end of the membrane.
