# FIELD AND LABORATORY ASSESSMENT OF SPF ROOF SYSTEMS

RENE M. DUPUIS

Structural Research, Inc.  
Middleton, Wisconsin

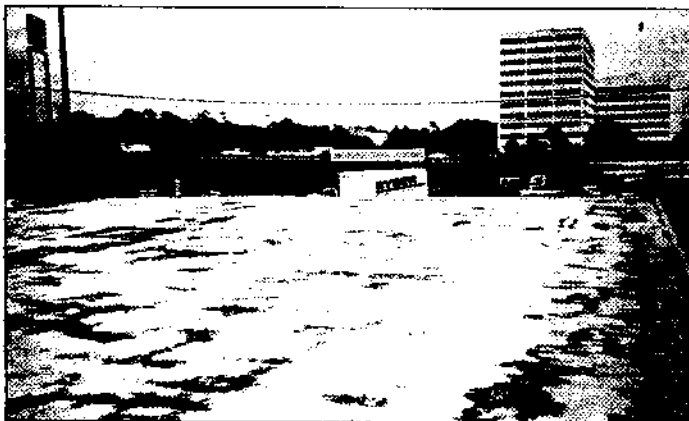
All of the coated roofs retained dirt to some degree and exhibited surface blemishes similar to that seen on white single-ply systems. Most of the discoloration and dirt could be attributed to building location and environmental conditions.

*Photo 1. The blotchy appearance of this light-colored roof is caused by dirt accumulation at birth baths.*
