THE PEMBROKE PROJECT: A FULL-SCALE DEMONSTRATION OF ROOF RE-COVER

J. C. PATTEN
Benchmark Inc.
Cedar Rapids, Iowa

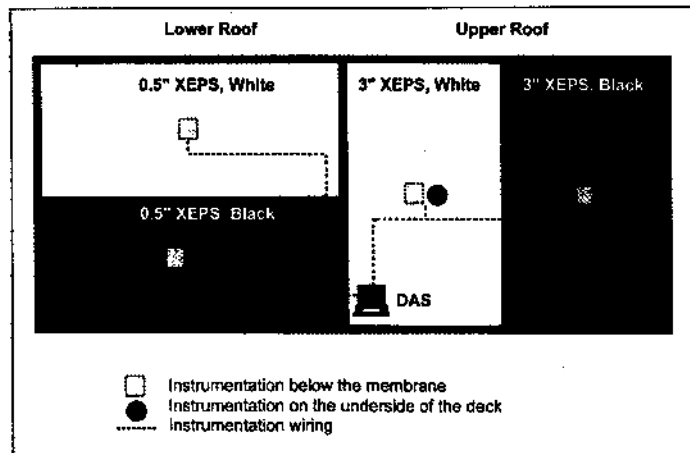
Figure 2. A schematic of the membrane and instrumentation layout employed on the Pembroke Municipal Building. Each roof plane was bisected and re-covered with a black and white single-ply membrane. Instrumentation was installed in the roof system to monitor the exterior membrane surface temperature and the building interior temperature and humidity.

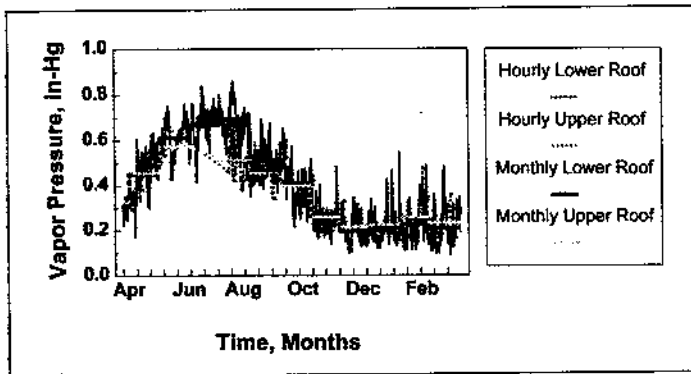
Figure 3. The hourly and monthly average vapor pressures under the lower and upper roofs of the Pembroke Municipal Building. The monthly averages were used as input to the simulation model.

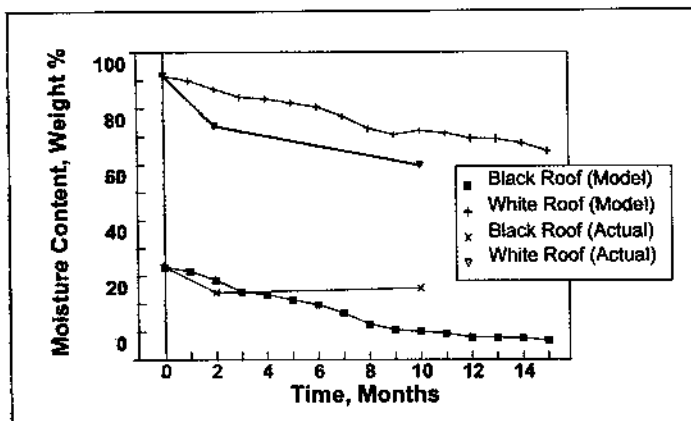
A comparison of the actual drying data and model predictions is presented in Figure 4. The model overpredicts the moisture content data calculated from the nuclear densimeter surveys by about 10 weight percent for the white membrane portion of the lower roof. This difference is equivalent to one count on the nuclear densimeter. Other possible reasons for this difference are some leakage into the building, air flow in the flutes of the deck, or higher permeability of the metal deck than was modeled. For the black membrane portion of the lower roof, the model agrees well with the first set of nuclear densimeter data but underpredicts the moisture content (or overpredicts the drying rate) of the second set of nuclear densimeter data by approximately 15 weight percent. Possible explanations for this variation include the sensitivity of the nuclear densimeter at lower levels of moisture content, the permeance of the metal deck, or the fact that the research team is averaging a number of locations that range from relatively dry to saturated, and the average is not similar to sum of the range of moisture contents present. Areas that are already relatively dry will dry no further and the nuclear densimeter will simply detect no change in moisture content for these locations. These areas, averaged with areas that are drying, will yield an average change in moisture

Figure 4. The measured and simulated moisture contents of the black and white membrane portions of the lower roof of the Pembroke Municipal Building. Time 0 is April 1996. See text for further details.

content that is less than the situation where all of the locations contain the same (average) amount of moisture. Additional data are needed to ascertain the cause of the differences noted between the modeled and measured levels of moisture content remaining in the roof; this data will be gathered during future visits to the building.
