Failure Mechanisms in Liquid-Applied Waterproofing Systems

Kami Farahmandpour, PE, RRC, CCA, CCCA

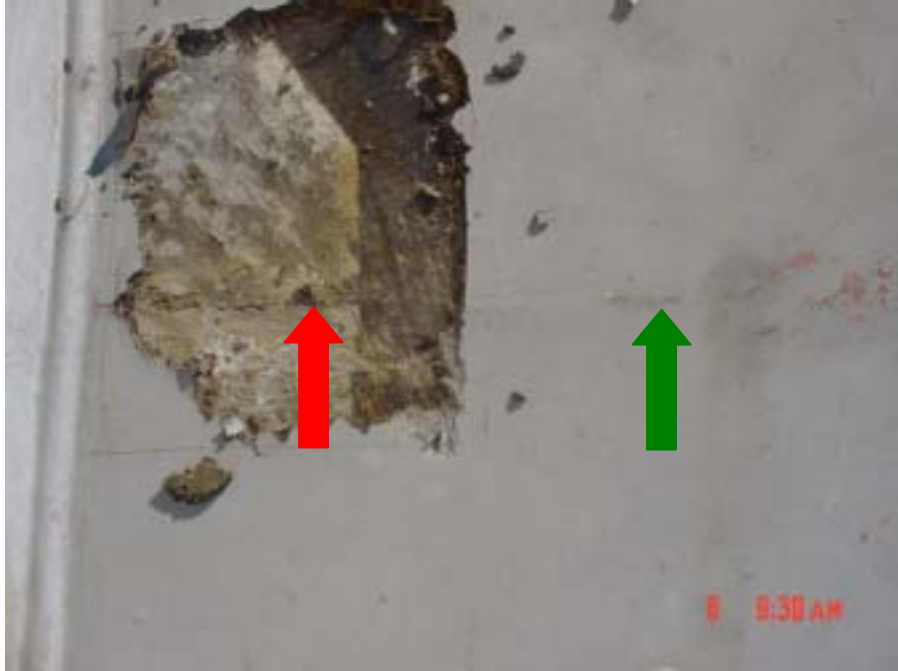
Figure 1 – Crack (tear) in a reinforced liquid-applied membrane (left arrow) coincides with substrate crack (right arrow).

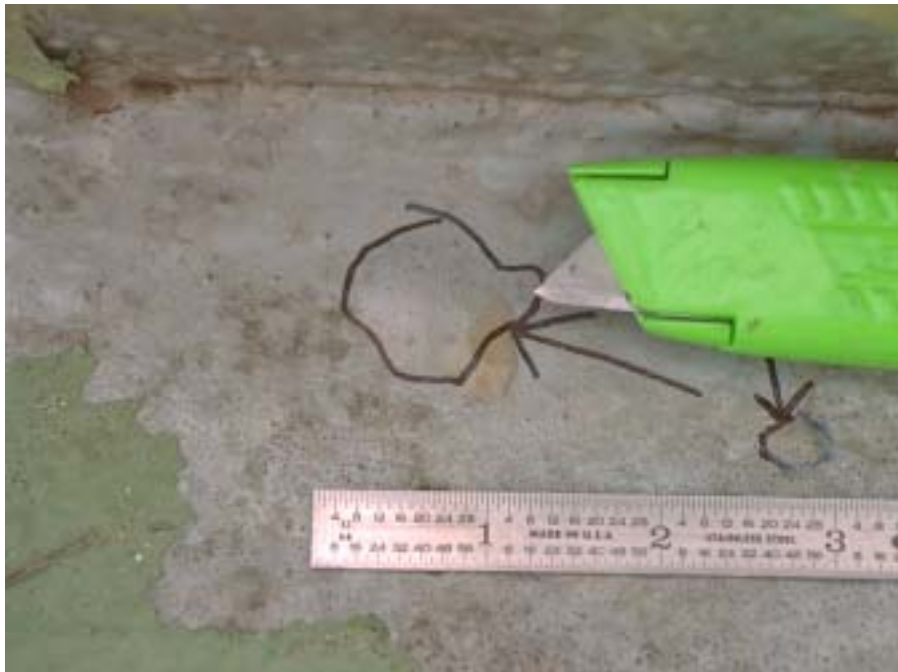
Figure 2 – Water-filled blister in a liquid-applied membrane.

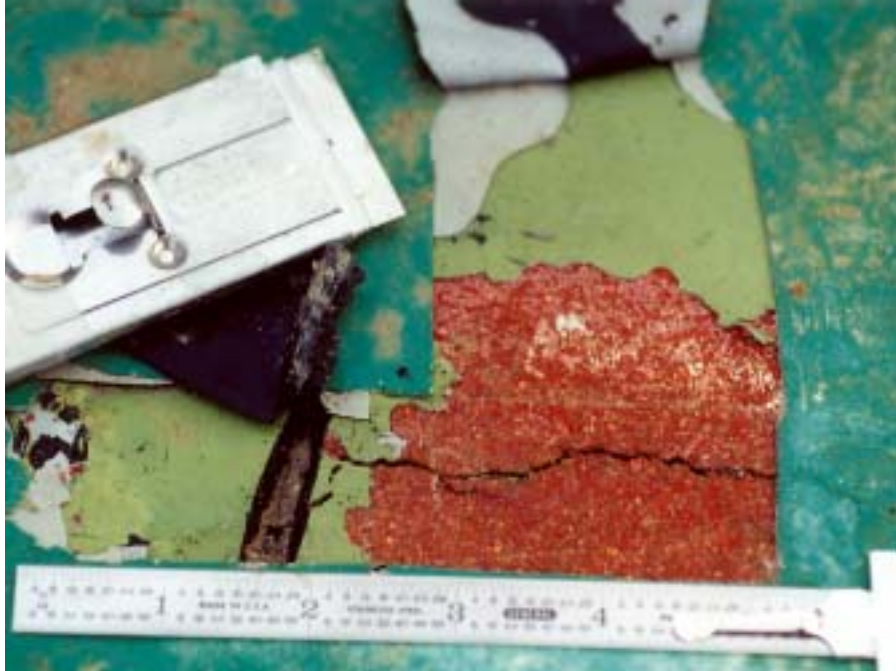
Figure 7 – Interlayer membrane delaminations at various interfaces. Note the substrate crack reflecting through the first light green application of the membrane.

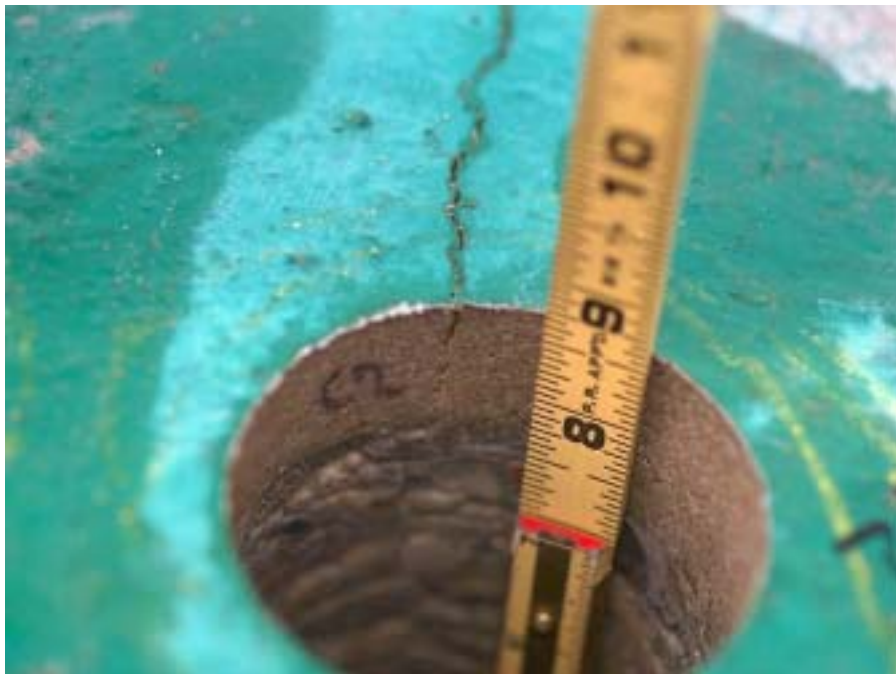
Figure 8 – Substrate crack reflecting through the membrane.

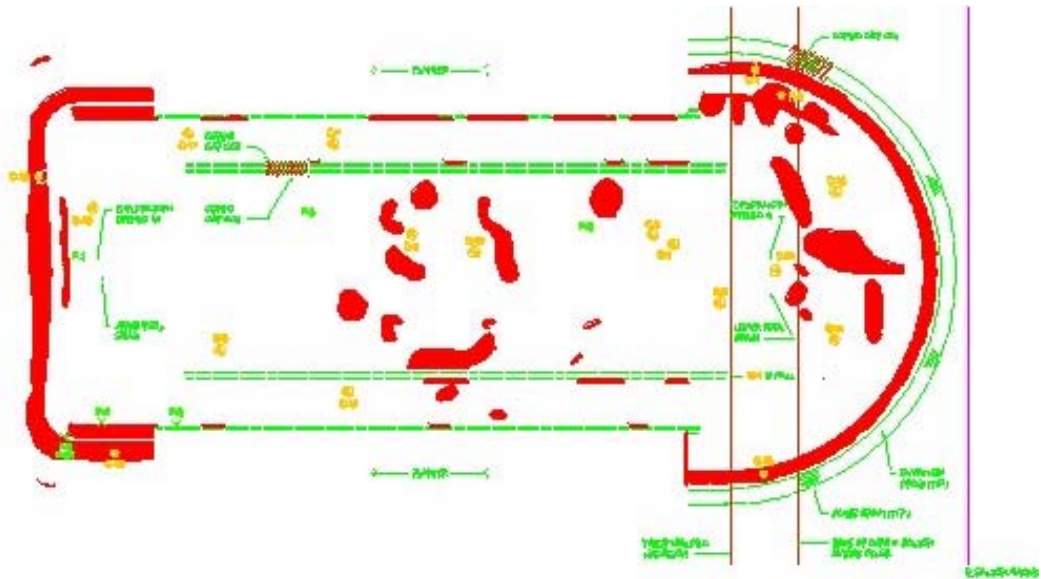
Figure 9 – Delamination survey results. Red areas indicate delaminations detected by sounding.

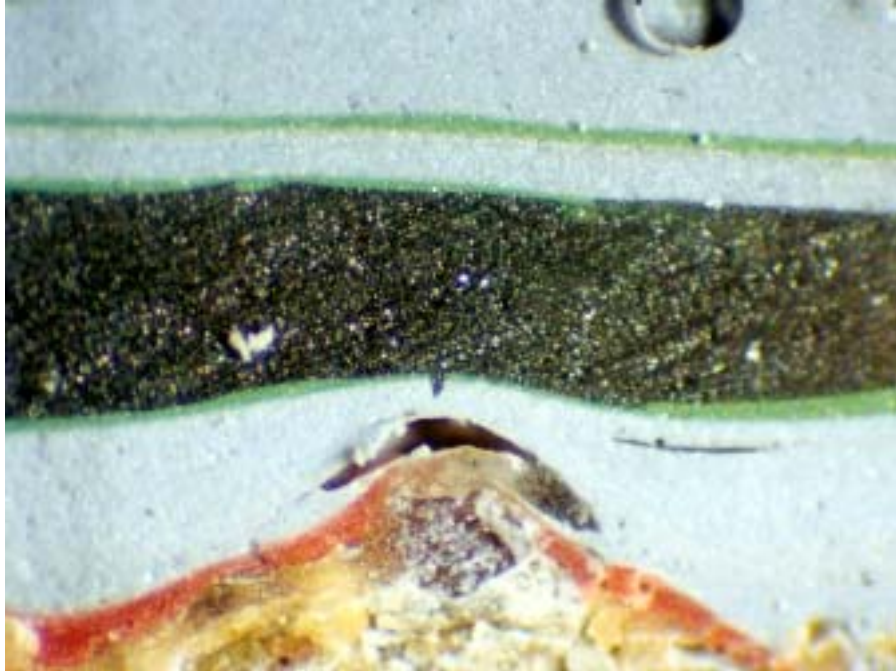
Figure 15 – Photomicrograph of a membrane blister directly over a substrate peak. The peak appears to have caused a breach in the primer (red material).
