MRCA Roof Coatings Research

-- A Progress Report --

MRCA Coating Research Program Photo Log

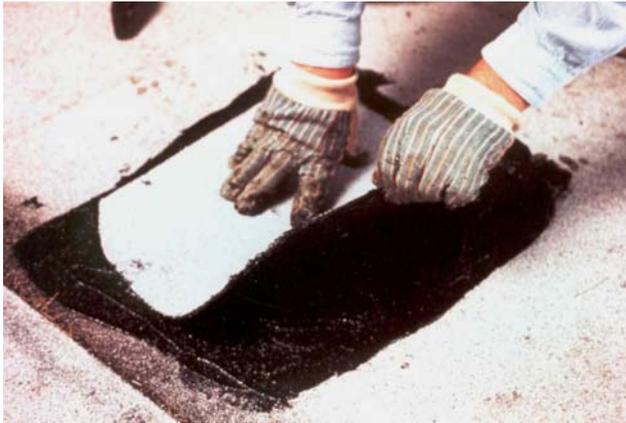
Roof maintenance generally involves administering spot repairs to patch or repair weather-weakened, deficient locations in a roof membrane (see Photo 1). After spot repairs have been made to smooth- and granule-surfaced roof membranes, roof maintenance can involve preparing the existing roof surface, then applying a surface coating or a combination of coatings to reduce the effects of direct weathering, thereby prolonging the life of the existing roof membrane (see Photo 2).

Photo 1: Shows installation of a spot repair at weather-weakened deficient location of roof membrane.

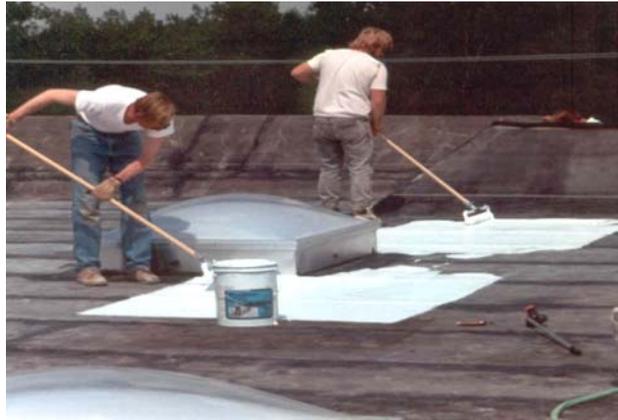
Photo 2: Application of surface coating to shield roof membrane from direct effects of weather and prolong life of roof membrane.

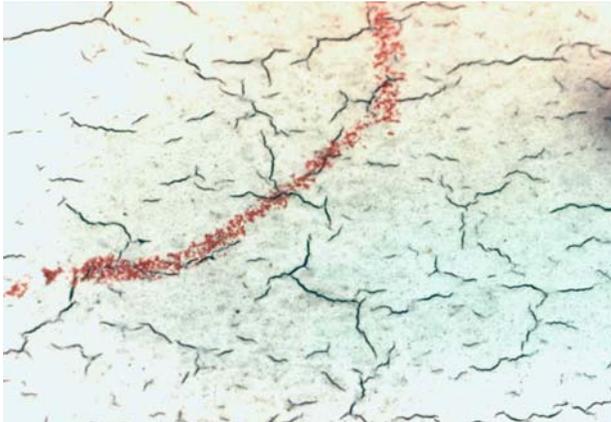
However, in some North American roofing markets, roofing contractors, designers and building owners have reportedly experienced frustration when using various coatings with specific roof membranes. For example, when several manufacturers of APP-polymer-modified asphalt roof membranes required the application of a liquid-applied coating as a condition of their roof warranties, but gave minimal guidance on when and how to coat the roofs. Various coatings degraded prematurely (e.g., yellowed, faded, asphalt bleed-through the coating, etc.). Some roof systems experienced difficulties with coatings that crazed, cracked, peeled, flaked off, or eroded and wore off prematurely (see Photos 3, 4 and 5 for examples).

Photo 3: Close up of initial cracking of surface coating.

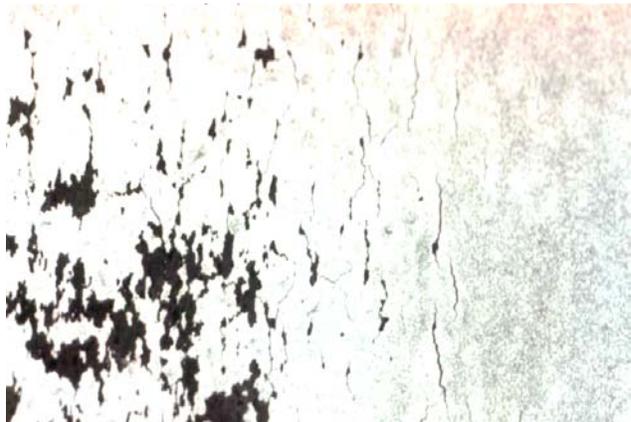
Photo 4: Shows initial cracking and peeling of surface coating.

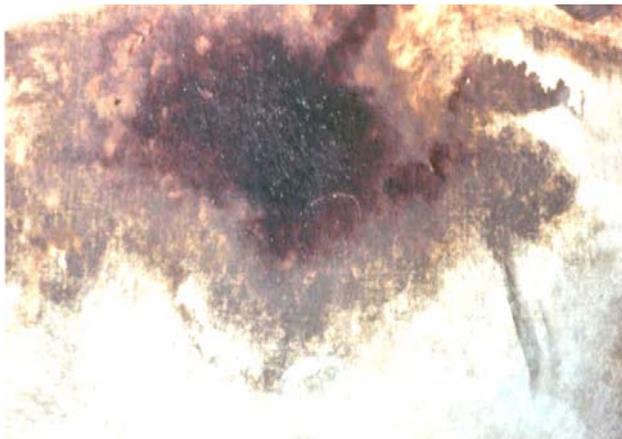
Photo 5: Shows accumulation of asphalt bleed-through on the surface of coating

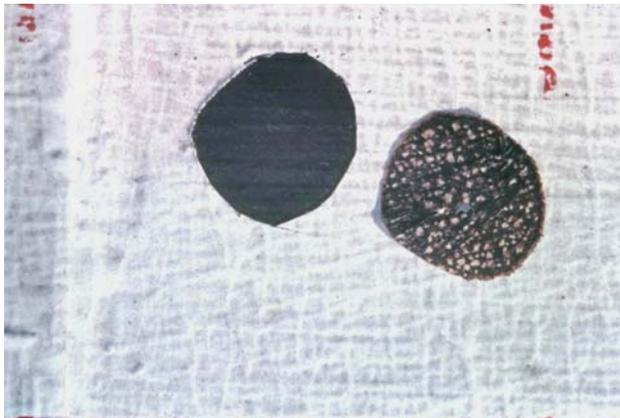
1. The asphalt emulsion primer appears to be acting as a buffer to minimize the bleed-through of light oils over the glazed BURs and commodity-grade, APP-modified asphalt membranes. Where primer was not used over these same membranes, the light oils of the asphalt bled through some of the coatings. In the areas where the membranes were primed with asphalt emulsion, it appears that the emulsion has served as a buffer and the asphalt's oils are not staining or degrading the hue of the coating.

Photo 13: White acrylic coating applied to an asphalt-based membrane primed with asphalt emulsion revealed increased adhesion and peel strength, as evidenced by well bonded emulsion on the bottom side of acrylic coating.

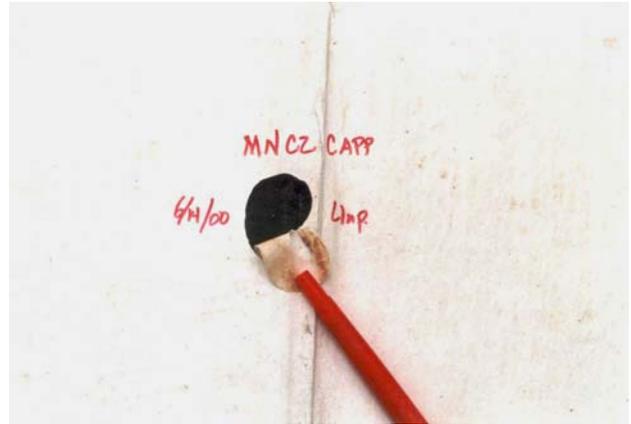
Photo 14: White acrylic coating applied to an asphalt-based membrane, that lacks asphalt emulsion primer, revealed less bond and peel strength. Note only minor traces of asphalt residue on the bottom side of acrylic coating.

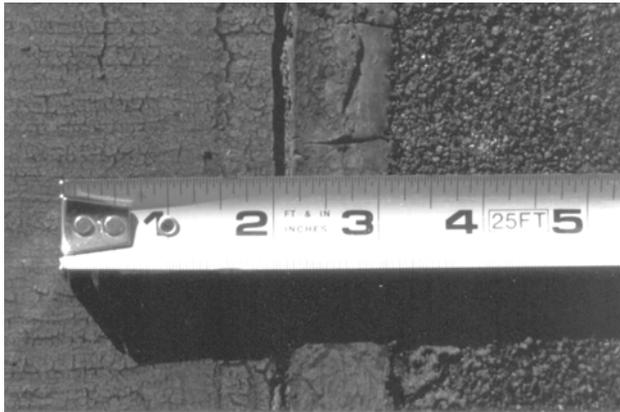
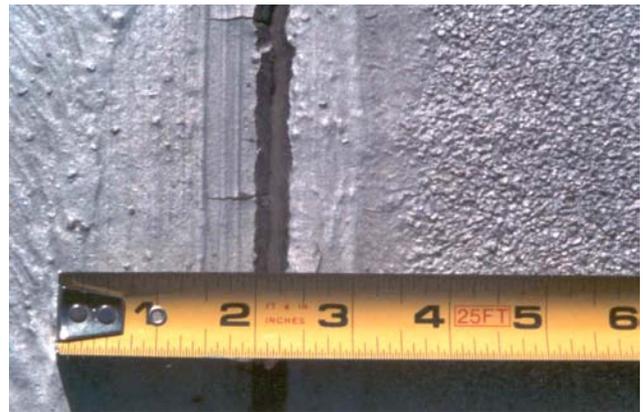
3. The emulsions and aluminum-pigmented coatings have stress-cracked and split directly over the end laps of the polyester-reinforced, SBS and commodity-grade, APP-polymer-modified asphalt membranes, indicating that these membranes are undergoing post application shrinkage (see Photos 15 and 16). However, at test areas where white acrylic coatings were applied over the same polyester-reinforced membranes, no stress cracks or shrinkage were observed in the coating over the end laps of the membranes (see Photo 17). This finding provides reason to believe that the white acrylics are moderating the thermal movement of the membrane, thereby keeping these polyester-reinforced sheets from noticeable shrinkage.

Photos 15 and 16: Stress cracks through emulsion and aluminum coating at end laps of polyester-reinforced, APP-Polymer-modified asphalt cap sheet indicates that membranes are experiencing post-application shrinkage.

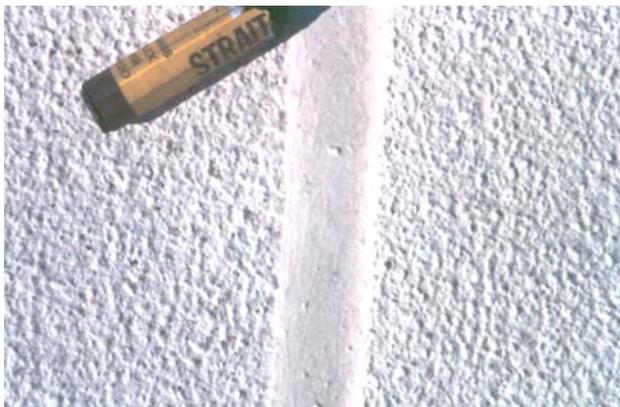
Photo 17: No stress cracks or shrinkage was evident at same SBS polymer modified asphalt cap sheet end laps coated with white acrylic coating.

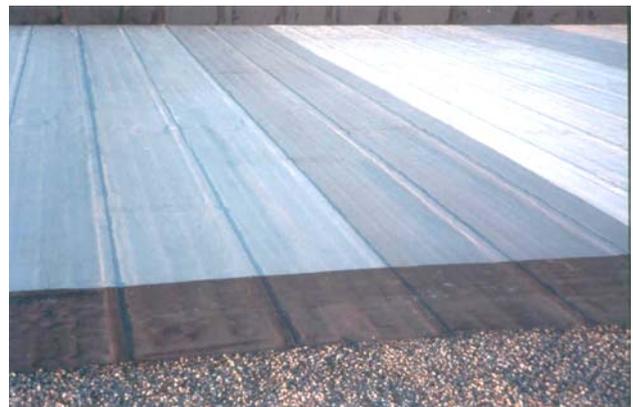
Photo 18: Overview of aluminum-pigmented, solvent-based SBS-polymer-modified and premium-grade coatings, as well as acrylic coatings that are performing well.

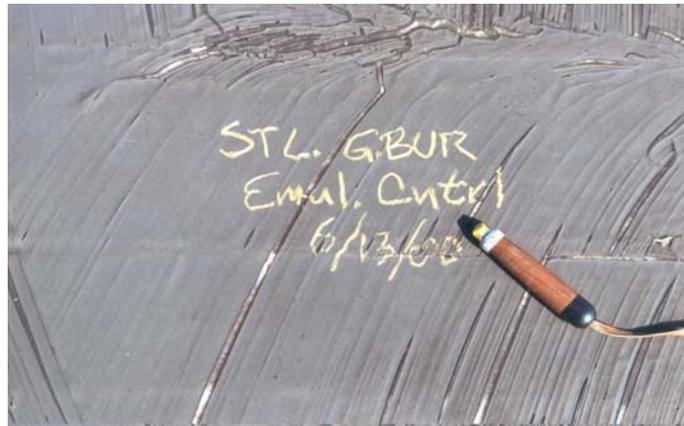
6. The black asphalt emulsion primed areas, which were left exposed as primed control areas, are showing some signs of cracking and erosion. This cracking is most pronounced where the lack of glazing craftsmanship during membrane application allowed the hot asphalt glaze coat to be applied too heavily, thereby promoting alligating of the glaze or "flood" coat of hot asphalt and the overlying emulsion primer (see Photo 19).

Photo 19: Depicts cracking and erosion of exposed asphalt-emulsion primer that was applied over hot asphalt glaze coat that was installed too heavy and is subsequently telegraphing, alligatoring/cracking through the overlying emulsion.
