MECHANICAL PROPERTIES EVALUATION OF POLYISOCYANURATE ROOF INSULATION BLOWN WITH CFC-11 SUBSTITUTES

THOMAS LEE SMITH

National Roofing Contractors Association
Rosemont, Ill.

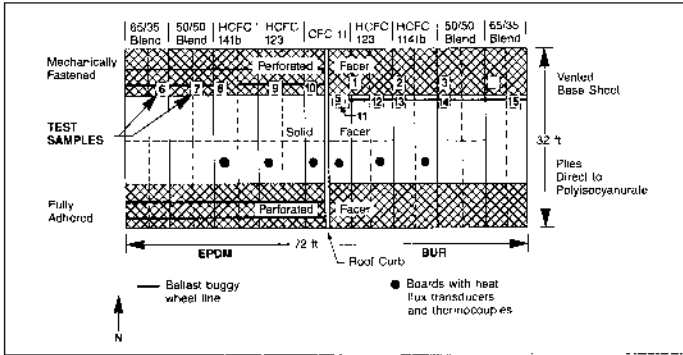
Figure 2 Locations of samples and thermal instruments.

After the base sheet and two ply sheets had been applied, a blister approximately 11 ft. long and 12 inches wide was observed. It occurred over 123 and 141b boards in an area with a perforated facer. It was not determined if the blister was below the facer, between the facer and base sheet, or between the ply sheets. The blister was stepped-in while the membrane was still quite warm (above 160°F). The next day, the blister was not noticeable. This area will be sampled in the future for further analysis.

One 18 in. by 18 in. sample was taken from each board type and examined with an eight power magnification scope. No board damage was observed (there was no indication of crushed cells, facer delamination, or core fracture). The samples are identified as numbers 1-5 (Figure 2).

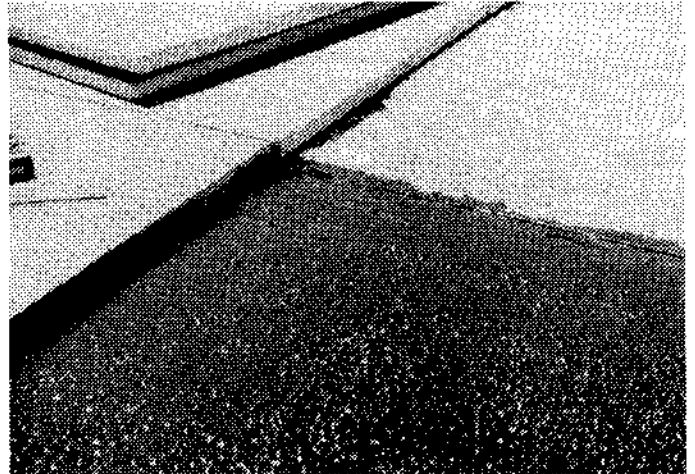
As the insulation boards were mopped, the asphalt frothed (bubbled) fairly uniformly (Photo 4). This was observed on all five of the insulation products. It occurred over the perforated and non-perforated facers, although frothing was not as pronounced over the perforated facers. Frothing was also observed earlier when asphalt was applied to the top of the mechanically attached boards.

Photo 4 Asphalt typically frothed (bubbled) when mopped over the insulation.

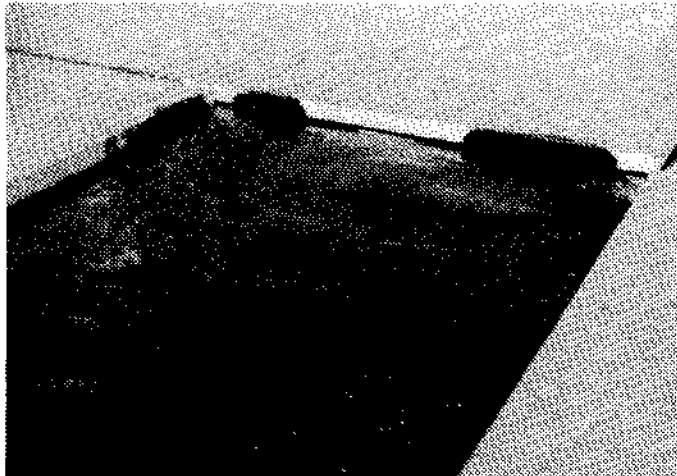
Blister development below the facer was most pronounced on the 123 boards (Photo 2), with blisters developing even when the mop cart temperature was 300°F. Blistering occurred to a lesser degree with the 141b and 50/50 boards, with the 50/50 boards being somewhat more affected than the 141b. Blisters were not observed with the 65/35 or CFC-11 boards. All of the observed blisters were on the non-perforated facers. However, blisters may have developed on Strip 1 unobserved, since the top board on Strip 1 was placed soon after mopping.

Dimensional stability (lifting/cupping) problems were pronounced with the 123 boards. Cupping occurred about each board axis (all board edges lifted). Dimensional stability problems occurred to a lesser degree with the 50/50 and 141b boards, with the 141b boards being somewhat more affected than the 50/50. Cupping was only apparent with respect to the long axis (the board ends lifted). Dimensional stability problems were not observed with the 65/35 or CFC-11 boards.

Photo 2 Blisters developed below facer on HCFC-123 board. Note the lifting of the edge of the 123 board in the upper part of the photo.

The blistering problem needs to be further explored by manufacturers prior to the commercialization of boards blown with 123, 141b, or with a 50/50 blend. For some unidentified reason, blistering problems were not observed with the 65/35 blend. With further respect to response to hot asphalt, many of the HCFC-123, HCFC-141b, and HCFC-50/50 boards experienced dimensional stability problems. The problem was most pronounced with the HCFC-123 boards.

The dimensional stability problem needs to be further explored by manufacturers prior to commercialization of boards blown with 123, 141b, or with a 50/50 blend. For some unidentified reason, dimensional stability problems were not observed with the 65/35 blend.

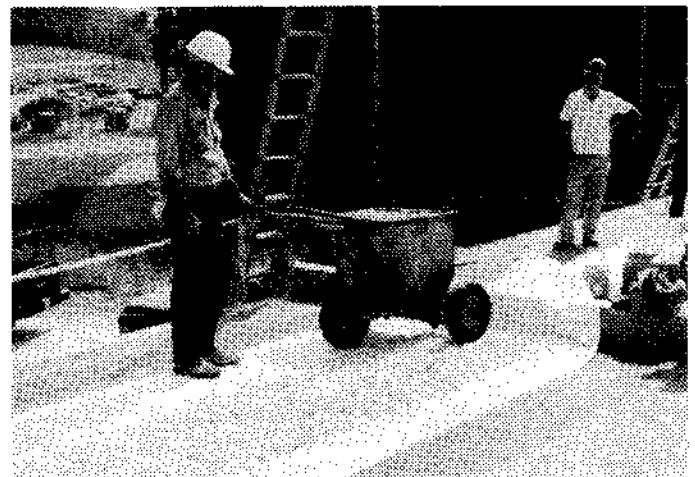
Photo 5 Crushing test: A loaded ballast buggy made five passes over EPDM covered insulation. Filter fabric and ballast was then placed over the EPDM and the loaded buggy made two additional passes. When passing over the insulation, the middle wheel of the buggy did not bear on the roof.

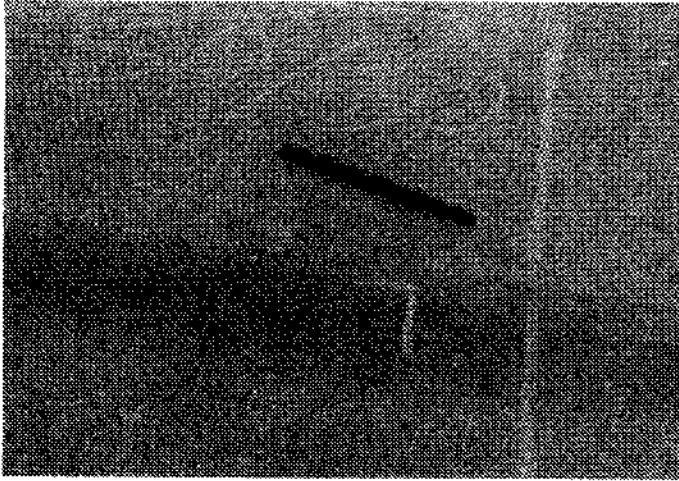
The aggregate and membrane were then removed and the face of the boards observed. There was minor facer damage, with the facer being depressed or ruptured in a few locations (Photo 6). There did not appear to be any significant difference in damage among the five insulation products. One 24 in. by 24 in. sample was then taken from each board type and examined with the eight power magnification scope. No board damage was observed (there was no indication of crushed cells, facer delamination or core fracture), other than for the few random depressions and facer ruptures that were caused by stones. The samples are identified as numbers 6-10 (Figure 2).

Photo 6 After the testing shown in Photo 5, the membrane was removed to observe the insulation. The small dots are the facer perforations. The only damage in this photo, which is of sample 7, are two facer ruptures. One rupture is just above the number "7," and the other is about 2 inches to the left. An ink pen is shown for scale.
