# THE ELECTRICAL EARTH LEAKAGE TECHNIQUE FOR LOCATING HOLES IN ROOF MEMBRANES

KEITH ROBERTS

Rollinson Glanville Consultants  
Abingdon, United Kingdom

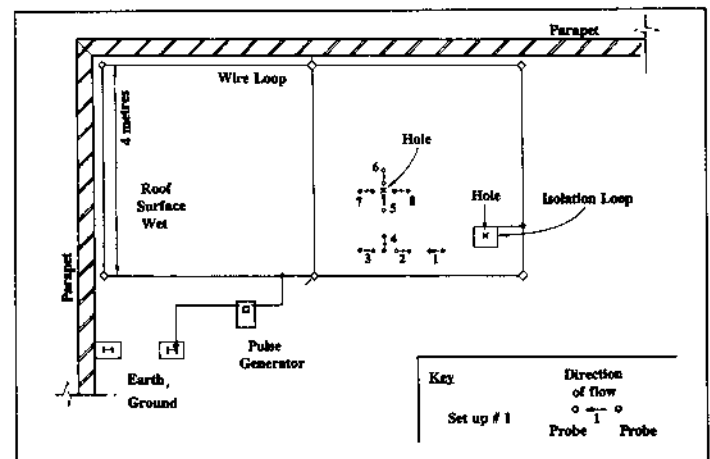
Figure 4. Roof plan showing area under test.

The other terminal is connected to the long length of wire, which is set out in a rectangular loop around the area to be tested. The pulse generator is switched on, a green light starts to flash, and a regular clicking noise is heard. The technician with the receiver and two metal probes then steps into the field to be tested and places the two probes onto the roof surface 1.5 m (5 feet) apart. The zero control is adjusted so that the ammeter is in the central position when there is no current flowing (Figure 4).
