Dents in Metal Roof Appurtenances Caused by Ice Ball Impacts

Scott J. Morrison, P.E.
Haag Engineering Co.
Carrollton, Texas, U.S.A.

During inspections of roof systems to evaluate hail-caused damage, useful information regarding sizes and hardnesses of hailstones can be estimated based on sizes of dents in metal roof appurtenances. This paper quantifies dent sizes in common metal appurtenances struck by freezer ice balls in simulation of hailstones.

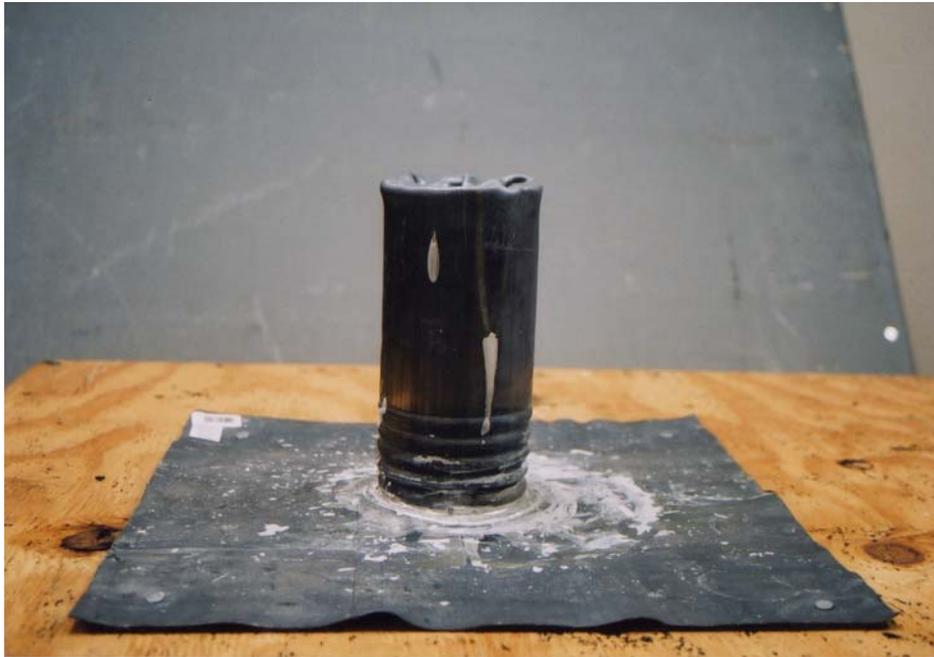
The tested lead soil stack flashing had a nominal 3-inch (7.6-cm) diameter and a base roughly 12 inches (30.5 cm) square. The material was approximately 0.045 inch (1.14 mm) thick. The flashing was slipped over a 3-inch (7.6-cm) (nominal) diameter polyvinyl chloride (PVC) plastic pipe projecting through and affixed to a test panel to mimic typical soil stack installations. The base was fastened to the test panel with four roofing nails, and the top end of the lead sleeve folded into the PVC pipe. See Figure 1.

Figure 1. Lead soil stack flashing.

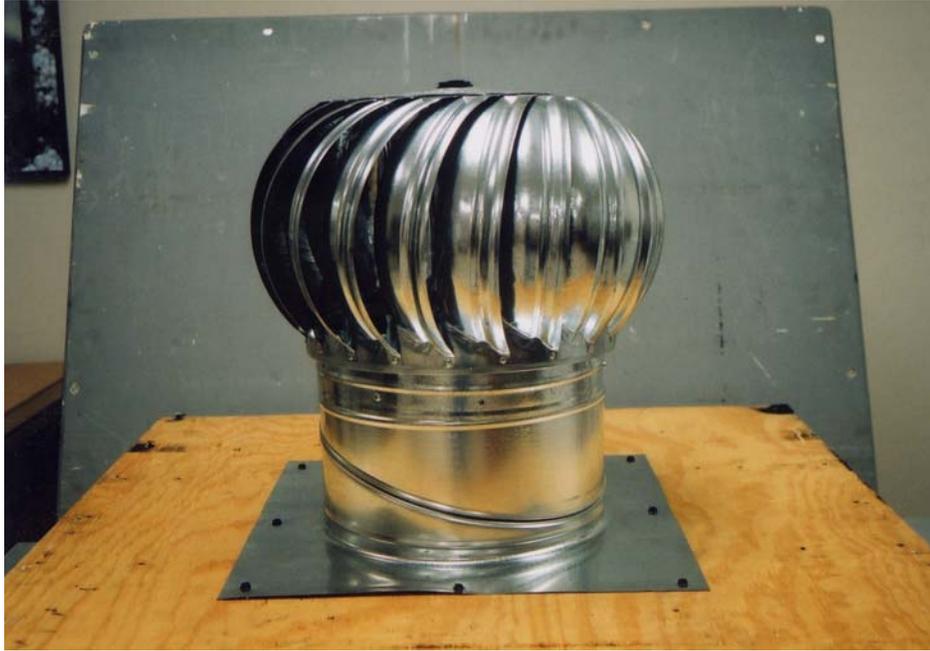
The turbine ventilator (turbine) had a 12-inch (30.5-cm) (nominal) size and, as supplied, was braced internally. Its overall height was 17 1/2 inches (44.5 cm), and its base was 18 inches (45.7 cm) square. Thickness of the ribbed metal blades measured approximately 0.032 inch (0.81 mm). Eight screws fastened the base to the test panel. See Figure 2.

Figure 2. Galvanized steel turbine ventilator.

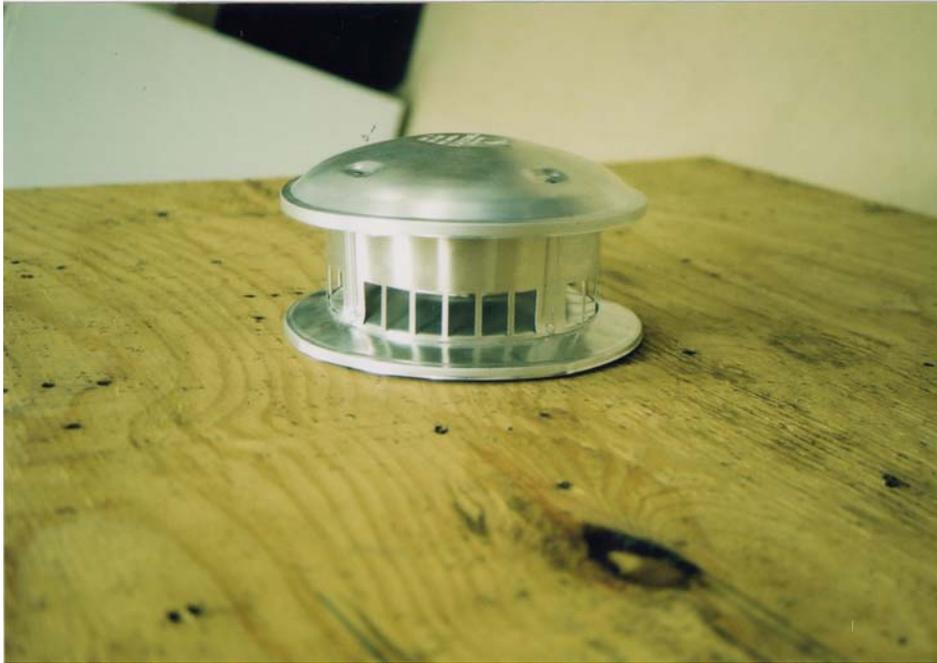
The aluminum cover was 6 inches (15.2 cm) tall with an ellipsoidal cap and 8 inches (20.3 cm) in diameter with a 1 1/4-inch (3.2-cm) crown. The metal thickness was approximately 0.020 inch (0.51 mm). The cover was clamped to a pipe secured with screws to the test panel. See Figure 3.

Figure 3. Aluminum cover for a water heater combustion products flue.

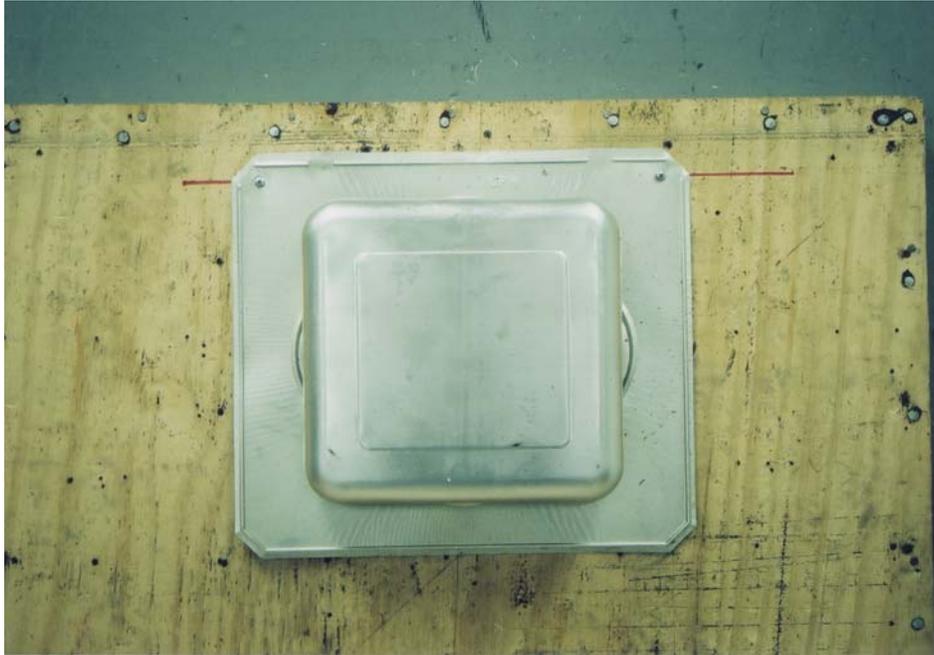
This vent comprised an open box-like form (cover) mounted over a base flashing with 9-by 9-inch (22.9- by 22.9-cm) projections. The cover measured 12 inches (30.5 cm) square and 3 inches (7.6 cm) deep; aluminum thickness was approximately 0.024 inch (0.61 mm). Two screws secured the base flashing to the test panel. See Figure 4.

Figure 4. Aluminum static vent.

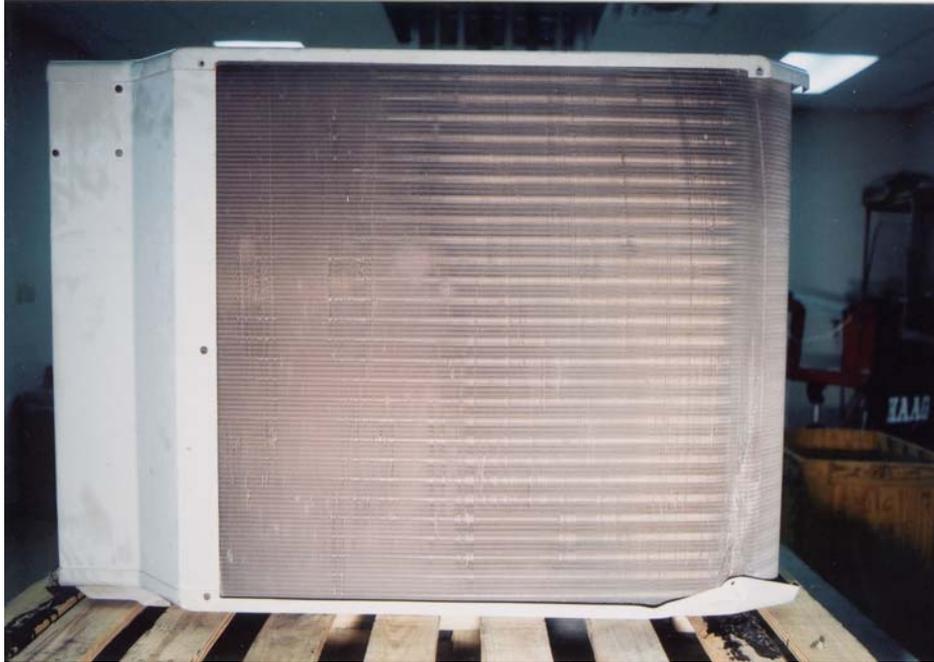
Aluminum fins of an air-conditioning unit condenser coil measured approximately 1 inch (2.5 cm) wide by 28 inches (71.1 cm) long by 0.007 inch (0.18 mm) thick. These fins were pierced and soldered at 1/16 inch (1.6 mm) intervals to copper condenser tubing 3/8 inch (9.5 mm) in diameter. Fins were mounted integrally within an air-conditioning condenser cabinet. See Figure 5.

Figure 5. Aluminum air-conditioning unit fins.

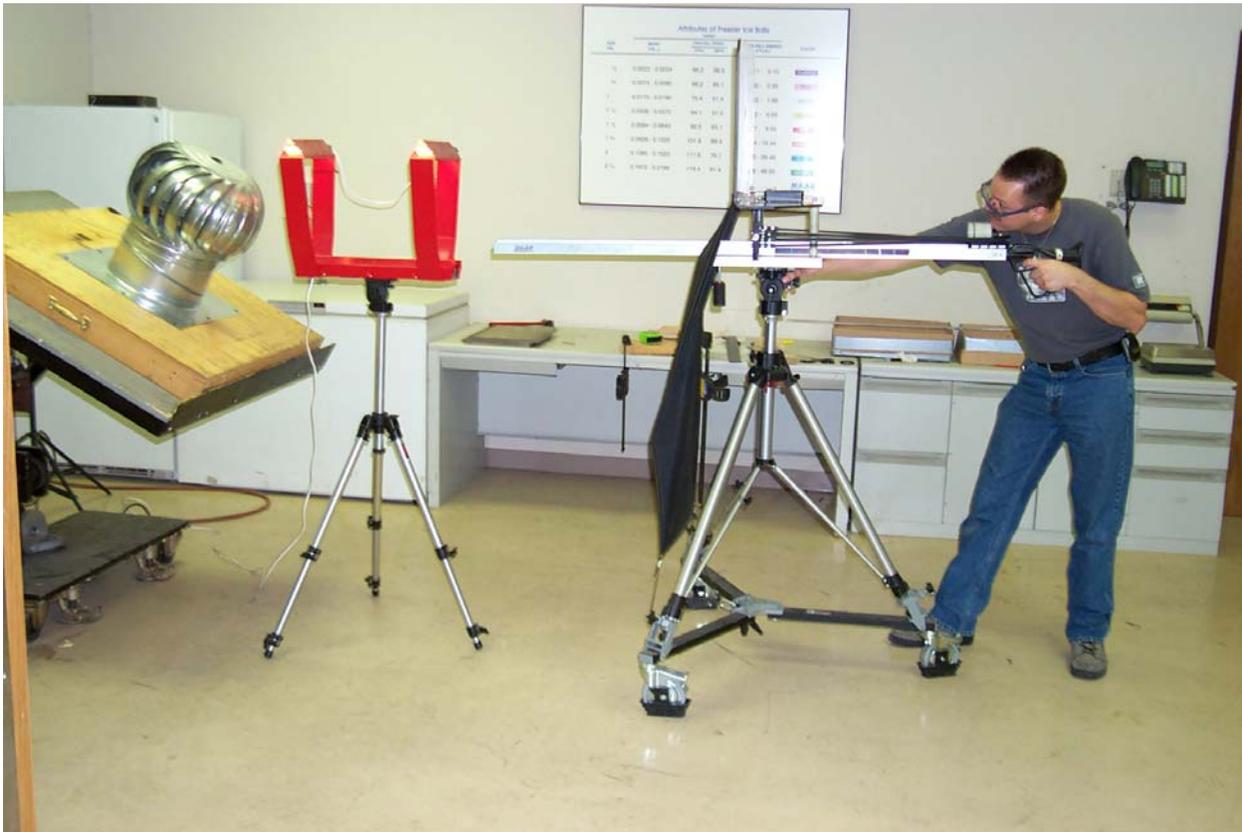
Appurtenances were inspected for damage and, except for the aluminum fins of the air-conditioning unit, mounted with fasteners driven through the base flashings to 3- by 3-foot (91.4- by 91.4-cm) test panels. The panel frames (perimeter elements plus third-span braces), built of 2 x 4 (nominal) lumber, were covered with 1/2-inch-thick (12.7-mm) plywood. Freezer ice balls, propelled to develop free-fall energies of same size hailstones, were launched against the appurtenances. These ice balls measured approximately 1/2 inch (12.7 mm), 3/4 inch (19.1 mm), 1 inch (25.4 mm), 1 1/4 inches (31.8 mm), 1 1/2 inches (38.1 mm), 1 3/4 inches (44.5 mm), 2 inches (50.8 mm) and 2 1/4 inches (57.2 mm) in diameter. The ice balls were frozen to desired sizes in molds and maintained at 0° F (-17.8° C) plus or minus 7° F (3.9° C). Ice balls were removed from the freezer, inspected by unaided eye for fractures, weighed and launched within 60 seconds at 90-degree or 45-degree angles of incidence against the appurtenances. The targets were conditioned for 24 hours at 72° F (22.2° C) plus or minus 3° F (1.7° C) before testing began. See Figure 6.

Figure 6. Test setup.

Locations of impacts were separated sufficiently that the dent caused by one did not influence a dent caused by another. Speeds of the launched ice balls were measured with a ballistics chronograph positioned within 1 foot (30.5 cm) of the target. Accuracy of the launch speeds was plus or minus 1 foot per second (0.30 mps). Ice ball weights and calculated kinetic energies were between 100 percent and 110 percent of free-fall kinetic energies or the datum was discarded. Table 1 lists target locations on appurtenances, and Table 2 lists particulars of the ice balls.

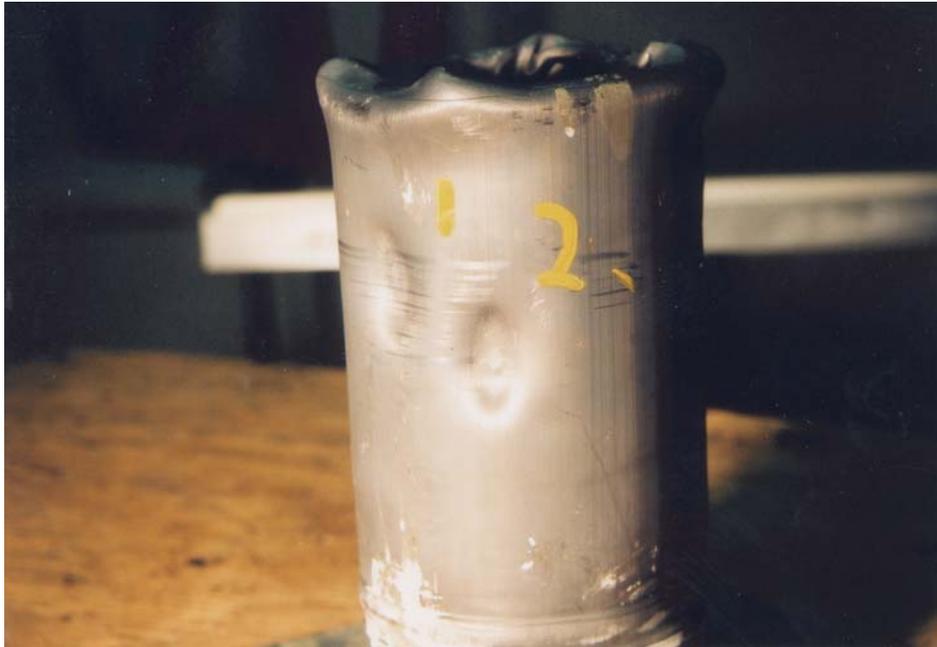
Figure 7. Dents in lead soil stack flashing from impacts at 45 degrees by 1 1/4-inch- (31.8-mm) diameter ice balls.

Deformations in the metal were examined by unaided eye, and their widths and depths were measured carefully. The dents were highlighted by rubbing a length of chalk across the impacted zone. Deformations were identified as *dents* when they were distinct and approximately the sizes of the impacting ice balls. A second category included *buckling of the metal*, deformations substantially larger than the projectiles. See Figures 7 through 11.

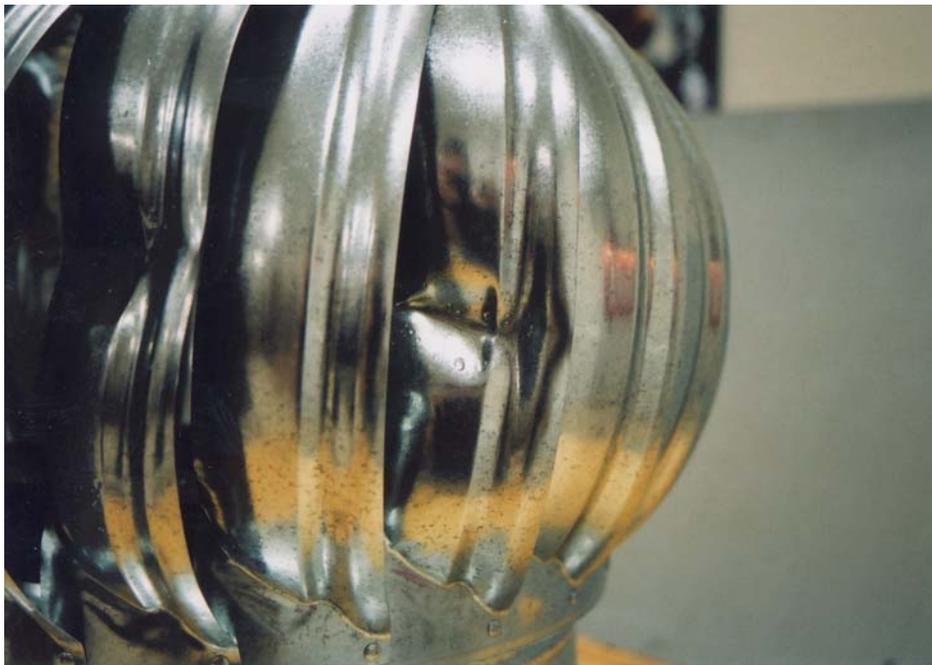
Figure 8. Buckle in the blade of a galvanized steel turbine ventilator from impact at 90 degrees by 1 1/2-inch- (38.1-mm) diameter ice ball.

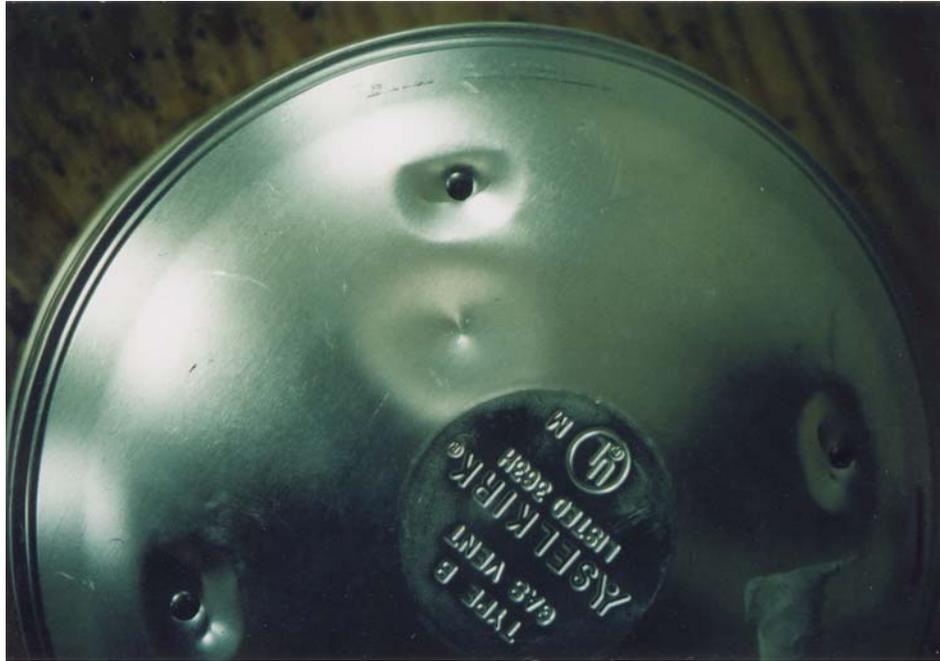
Figure 9. Dent in the aluminum cover for a water heater combustion products flue from impact at 90 degrees by 1/2-inch- (12.7-mm) diameter ice ball.
