MECHANICAL PROPERTIES EVALUATION OF POLYISOCYANURATE ROOF INSULATION BLOWN WITH CFC-11 SUBSTITUTES

THOMAS LEE SMITH

National Roofing Contractors Association
Rosemont, Ill.

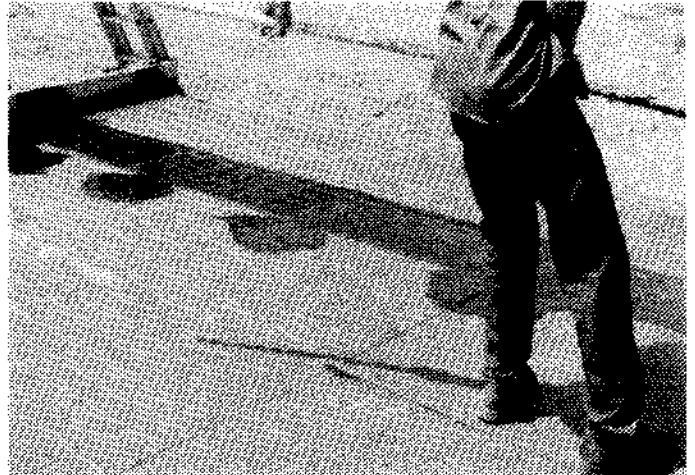
Photo 3 The base sheet was attached with spot mopping of asphalt in the field of the sheet. At the laps, the mopping was continuous as shown.

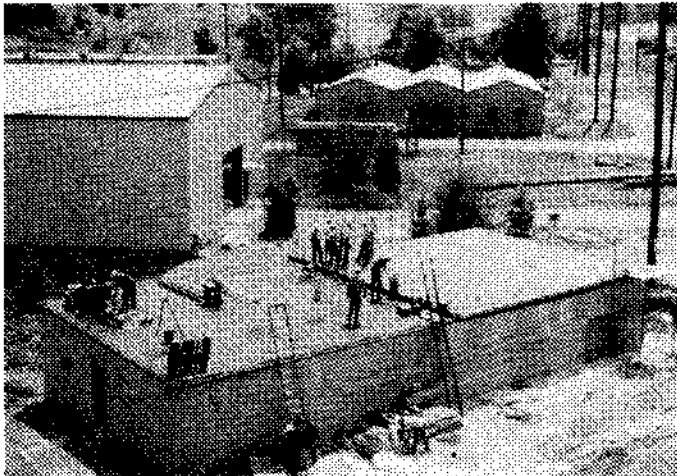
Photo 1 View of RMPRA (looking south). BUR section is on the left. Fully adhered EPDM section is on the upper right. Mechanically attached EPDM is on the lower right. Small, low building is the RTRA.
