# FIELD AND LABORATORY ASSESSMENT OF SPF ROOF SYSTEMS

RENE M. DUPUIS

Structural Research, Inc.  
Middleton, Wisconsin

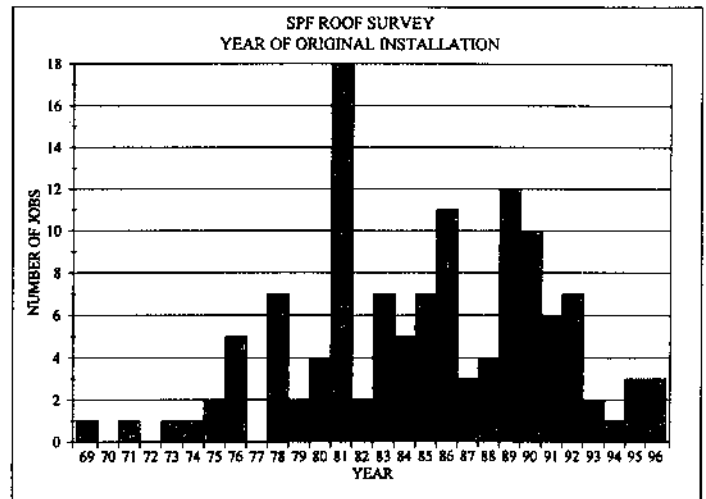
Figure 1. Year of installation for 125 SPF roofs surveyed; 15 roofs are not shown since date of installation is unknown. Age distribution shown is due to selection process used in study.

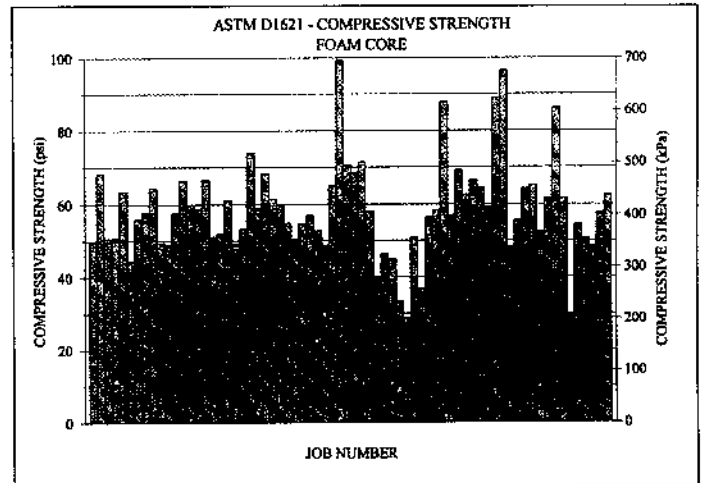
Laboratory work was done on core and slit samples to determine coating condition, color and thickness. Foam core properties such as moisture content, apparent core density and compressive strength were determined. Compressive strengths were determined using ASTM D 1621. The average compressive strength for all samples was 404 kPa (58.6 pounds per square inch [psi]). The highest compressive strength was 685 kPa (99.3 psi) and the lowest compressive strength recorded was 199 kPa (28.8 psi). The core sample containing the highest compressive strength was located on a large administration building in upstate New York that was installed in 1975 and coated with silicone. The moisture content of this foam core was 0.79 percent by weight; the apparent core density was 56.4 kg/m<sup>3</sup> (3.52 pounds per cubic foot [pcf]). The core sample having the lowest compressive strength was taken from a manufacturing plant roof in New Jersey that was installed in 1983 with aggregate surfacing and no coating on the foam. The moisture content for this foam core was 3.11 percent by weight with an apparent core density of 31.2 kg/m<sup>3</sup> (1.95 pcf). The range of compressive strengths is shown graphically in Figure 2. Minimum compressive strength for SPF roofs is currently 276 kPa (40 psi) at yield or 10 percent deformation, whichever comes first per *The NRCA Roofing and Waterproofing Manual—Fourth Edition*.

Figure 2. Foam core compressive strengths for all cores tested.

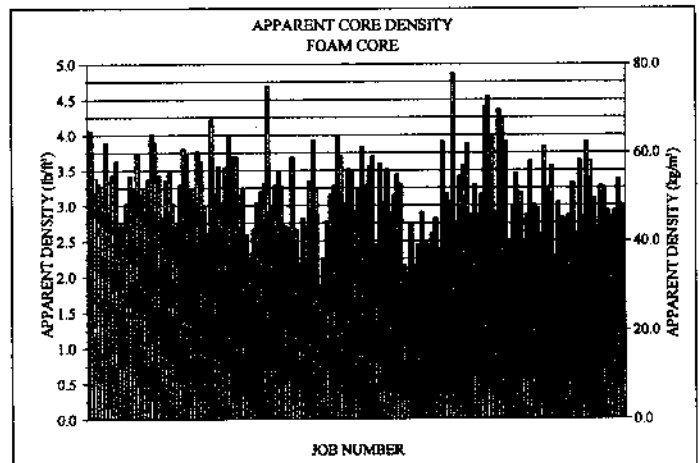
The apparent core density was determined by ASTM D 1622 with the average apparent core density of 51.6 kg/m<sup>3</sup> (3.22 pcf) for all samples. The highest core density was 78.0 kg/m<sup>3</sup> (4.87 pcf) and the lowest core density was 30.1 kg/m<sup>3</sup> (1.88 pcf). The roof containing the highest apparent core density was a manufacturing plant in northwestern Wisconsin that was installed in 1974. This core sample had a moisture content of 1.07 percent by weight. A compressive strength test could not be run on the sample due to its minimal thickness. The roof having the lowest apparent core density (30.1 kg/m<sup>3</sup>) [1.88 pcf] was a shop facility in southern California that had been installed in 1978 and recoated in 1985. The moisture content of this core sample was 1.61 percent by weight. A compressive strength test could not be run on this sample due to minimal thickness. A plot showing the range of apparent core densities can be found in Figure 3. As shown by the plot, the vast majority of the apparent density values occur in the 44.1 kg/m<sup>3</sup> to 60.1 kg/m<sup>3</sup> (2.75 to 3.75 pcf) range. Recommended minimum foam densities have risen over the years; since 1990, most specification have called for a minimum of 44.9 kg/m<sup>3</sup> (2.8 pcf). A plot of the compressive strengths versus core deformation is shown in Figure 4. A large number of foam core specimens yielded prior to 10 percent deformation, generally in the range of 6 percent to 8 percent.

Figure 3. Apparent foam core density for all cores tested.

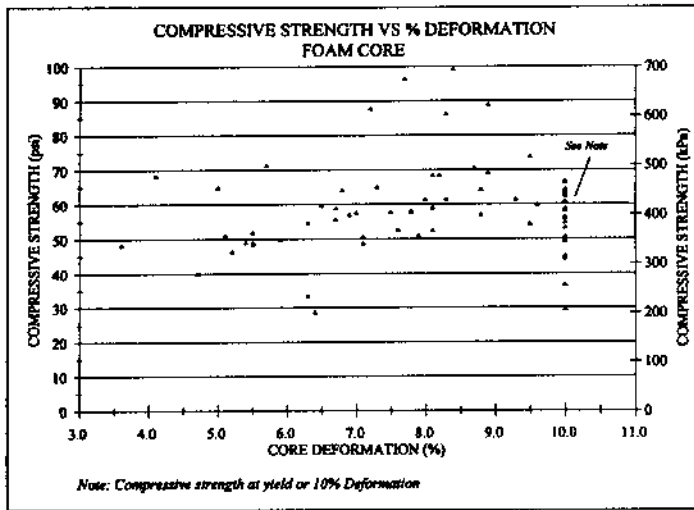
Figure 4. Compressive strength versus core deformation.

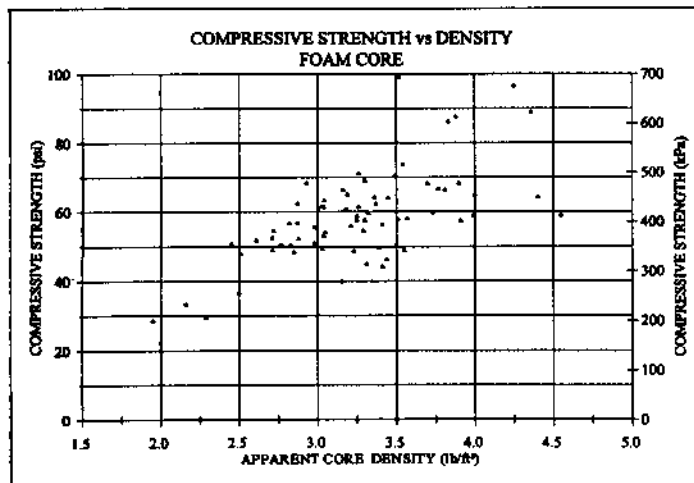
The relationship between compressive strength and apparent core density is shown in Figure 5. The higher density materials have higher compressive strengths as expected. The data scatter can be due to a number of variables, including formulation and field application. The age of these foam core specimens ranges from less than one year to 21 years old. The newest SPF roof had a core density of 64.1 kg/m<sup>3</sup> (4.0 pcf) with a compressive strength of 448 kPa (65 psi). The 21 year old roof had a density of 56.4 kg/m<sup>3</sup> (3.52 pcf), with a corresponding compressive strength of 685 kPa (99.3 psi) as mentioned.

Figure 5. Compressive strength versus apparent foam core density.

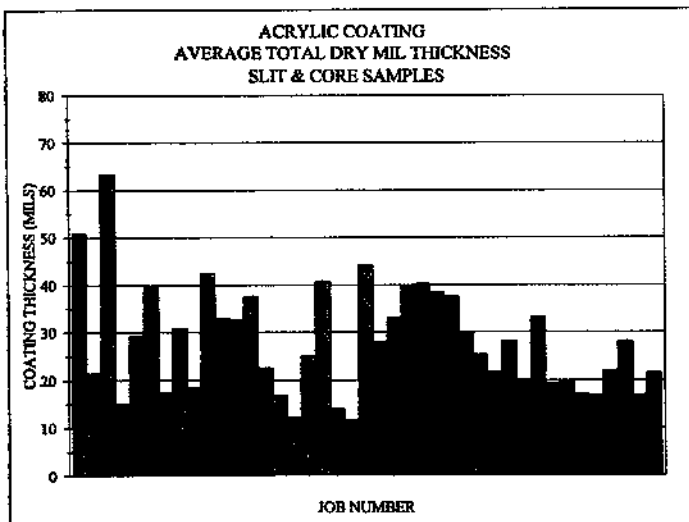
The total dry mil thicknesses of the coated SPF roofs were determined from core samples and slit samples taken during the survey. The average coating thickness for each acrylic roof is shown in Figure 7. These values include recoated systems as well as original acrylic coatings. The acrylic coating thicknesses ranged from a high of 63.4 mils to a low of 11.7 mils. The SPF roof with 63.4 mils was originally installed in 1981 and recoated in 1995. The SPF roof with 11.7 mils of acrylic coating was installed in 1995.

Figure 7. Average total dry mil thickness for acrylic coatings.
