# Project Pinpoint data reveal roof systems' strengths, limitations

Data collected from 1993 through 1995 disclose extent of problems encountered by several roof system types

by William C. Cullen and Mark S. Graham

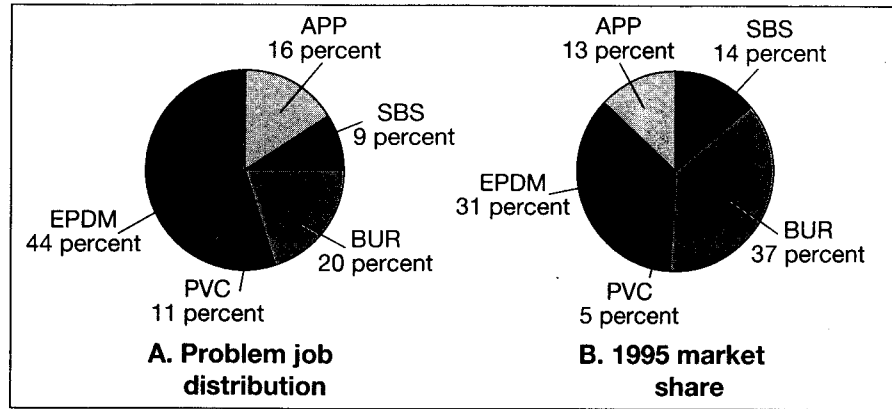
Figure 1: A comparative look at problem job information vs. market share.

information taken from the 1995 NRCA Annual Market Survey is used to roughly compare the number of problem jobs with roof membrane market shares (see Figure 1).

Pie chart A in Figure 1 illustrates problem job distribution of membrane systems as reported from 1993 through 1995. In the problem job grouping, EPDM and BUR systems accounted for 44 and 20 percent of the problem jobs reported, respectively, while the APP- and SBS-modified bitumen and PVC systems

followed with 16, 9 and 11 percent, respectively. In contrast, pie chart B in Figure 1 reveals the 1995 market share distribution of the same five membrane systems to be: 37 percent BUR; 31 percent EPDM; 14 percent
