HAIL RESISTANCE TEST OF SPRAYED POLYURETHANE FOAM (SPF) ROOF SYSTEMS

DEAN T. KASHIWAGI, MANOJ K. PANDEY, and THOMAS TISTHAMMER

Arizona State University
Tempe, Arizona

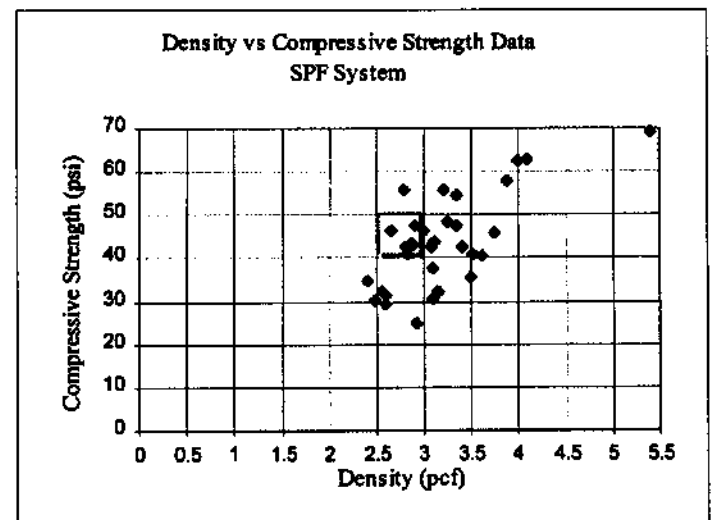
Figure 3. Density vs. compressive strength data for HCFC in-field SPF system (uncorrected for elevation), 1995.

Data collection has shown that there are also variances in installed SPF compressive strengths and densities.⁸ Figure 3 shows that only seven out of 33 random in-field samples of SPF from roof installations installed by performing contractors in 1995 met the manufacturer-specified 38 to 48 kg/m³ (2.5 to 3.0 pcf) density and 262,002 to 344,740 N/m² (38 to 50 psi) compressive strength requirements.² The fluctuation in the SPF system application lead to higher variation in SPF physical properties, which may place a higher hail-resistance requirement on the elastomeric coating system. These variations in installed SPF roof systems lead to a high level of risk and confusion toward liability of premature failure of SPF systems caused by hail damage. The lack of understanding of SPF roof systems' behavior may result in the marketing of coated SPF roof systems with no proven performance history of hail damage resistance in areas with severe hailstorms and

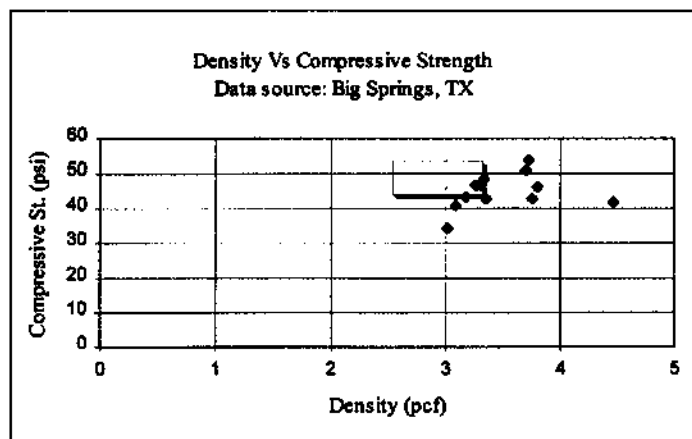
Figure 4: Density vs. compressive strength analysis.

Big Springs and the surrounding area experienced heavy hailstorms on May 10, 1996. The damage to property and crops was estimated at \$25 million. Most of the property damage was caused by softball-sized hailstones.¹⁰ SPF roof systems at the middle school were impacted by the hailstones. The indentations created by the hailstones were measured a year and a half after the hailstorm (the results are shown in Table 5). The polyurethane-coated system, which had an average coating thickness of 1.14 mm (45 mils), 48 kg/m³ (3.0 pcf), and 310,266 N/m² (45 psi) compressive strength average SPF, withstood up to at least 76.2-mm- (3-inch-) diameter hailstones (refer to Table 3). The correlation between density and compressive strength shows that the samples that resisted the impact of oversized hailstones met the criteria specified by the manufacturers (refer to Figure 4).
