WIND LOAD RESISTANCE TESTS OF HEAT-WELDED JOINTS BETWEEN ROOFING FELT AND SHEET METAL FLASHINGS

Fredrik Gränne* and Folke Björk

Kungl Tekniska Högskolan, Division of Building Technology
Stockholm, Sweden

ABSTRACT

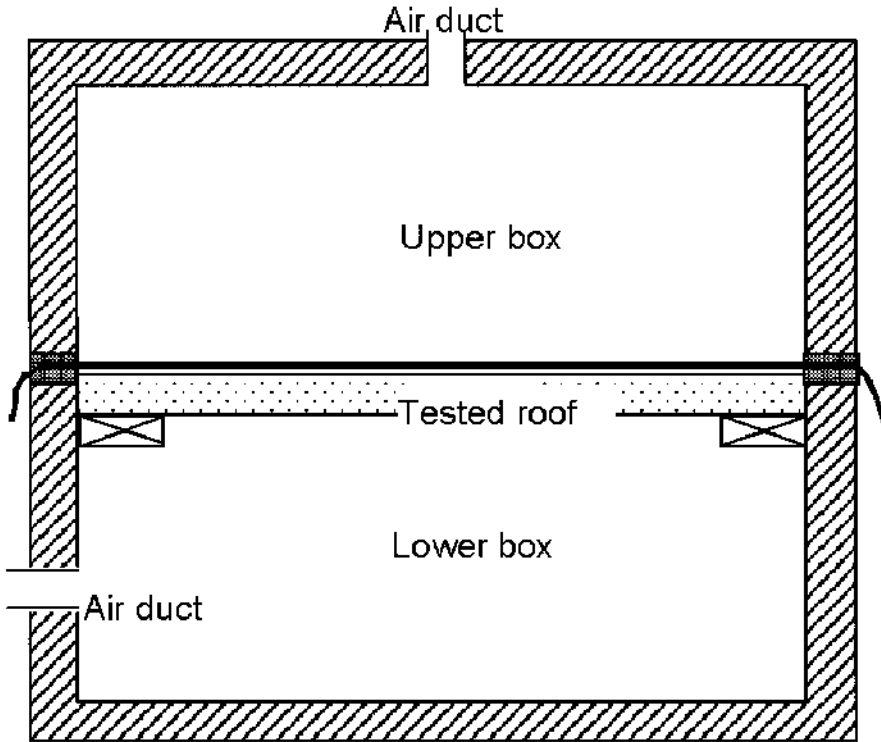
The large-scale test procedures were conducted according to NT Build 307 [5], which is a Nordic standard for large-scale test of roofing systems. The scope of the standard is to test the whole roof system including the membrane itself, the joints and the fasteners. The facility used for this test was situated at the Norwegian Building Research Institute in Trondheim. The test process contains both static and pulsating pressure that follows a program described in Table 3. The tests were carried out in a wind chamber as sketched in Figure 1. The chamber consists of the boxes; the upper and lower. A positive pressure is applied in the lower box and a negative pressure is applied in the upper box to simulate wind forces over the roof area. The boxes are separated by a roof deck on which the tested roof cover is mounted.

Figure 1. The wind-chamber at NBI.

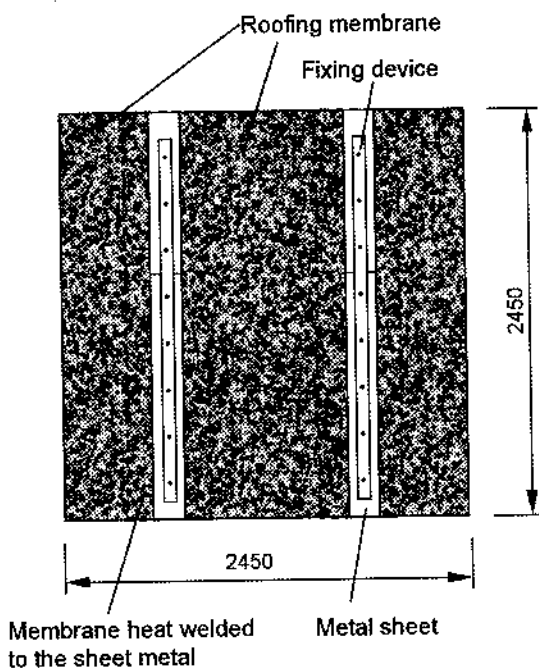
In this project the emphasis is to the strength of the joint between the membrane and the metal sheet. Therefore are the tested roof areas differently made than usual. Metal sheets are mounted on the roof deck and the membranes are heat-welded to them. To insure that the weakest area is in the joint between the metal sheet and the membrane, no joints in the membrane itself are present and the fasteners are positioned in the metal sheet and are over-dimensioned. A sketch of the tested roof area can be seen in Figure 2. The dimensions of the roof deck are 2,45 x 2,45 m [6].

Figure 2. The test roof with roofing membrane and sheet metal.

With the roof area shaped like in Figure 2, two joints along the whole roof's length are subjected to the maximum wind force. The outer joints were not subjected to very high load but they were necessary to make the roof airtight and were used as a reference.

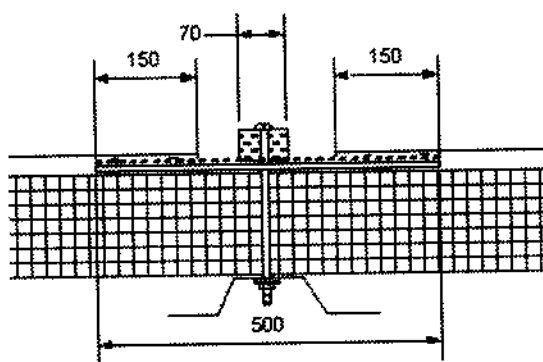
Figure 3. Detail of the joint between roofing membrane and sheet metal and the fixing device.

The metal sheets were nailed to a plywood sheet in a zigzag pattern with a 150 mm separation. The plywood was only present underneath the sheet metal and did not lie on top of the substrate, which was built up of 100 mm high density mineral fibre board over troughed sheet metal. The membranes were heat-welded to the metal sheet with a 150 mm overlap. All membranes were heat-welded with an open gas flame and in addition a roof was also made with SBS1 heat-welded with hot air from an encapsulated flame, see Table 2. The welding was performed by skilled workers.

To fix the roofing layer to the substrate, the sheet metal was anchored to the troughed sheet metal with screws through the mineral fibreboard.

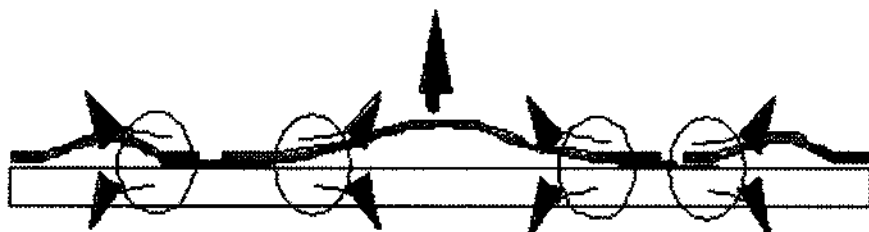
Figure 4. Section of test roof with arrows indicating strains induced by wind uplift.

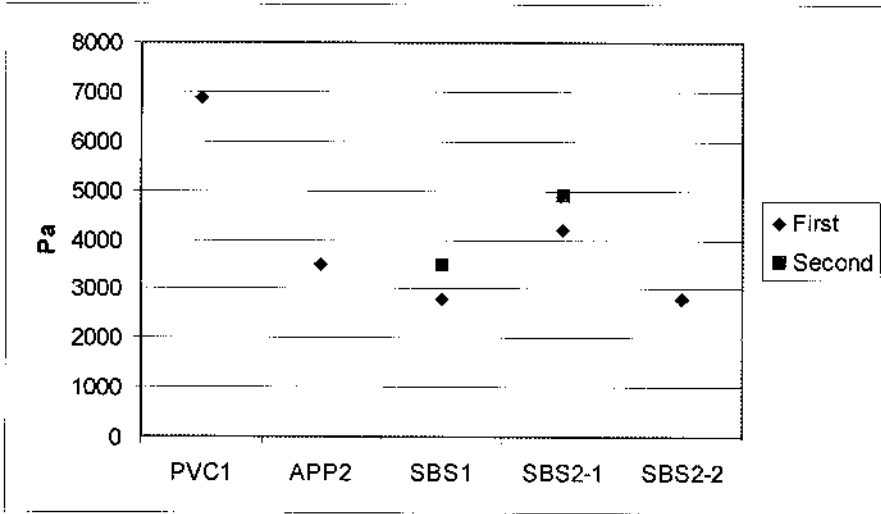
All roof systems were tested in the wind chamber until failure of the joints. One system was even tested with two different welding techniques (SBS2-1 and SBS2-2); open flame respective hot air. In two of the systems (SBS1 and SBS2-1), the

strength was different in the two main joints. After the first joint had failed it was repaired and reinforced and then the process continued until the failure in the other joint was recorded. This was practised to ensure that the failure first recorded was not due to a local defect. All results are compiled in Figure 6.

Figure 6. Wind chamber results. Failure strength in the joints between metal sheet and membrane.

As can be seen in Figure 6, the SBS2 joint made with hot air welding was somewhat weaker than the one made with open flame although still of the same magnitude as the other SBS material. After the failure of the joint the materials were torn apart and the weldings were examined. Very often, a pattern could be seen in the welding. The pattern in the joints is sketched in Figure 7. The cause of this pattern is uneven compression of the joint during welding. Where the pressure has been higher, the bonding between the materials was significantly better. During the welding process, the worker used his feet to compress the joint. Consequently, the pattern in the welding is the pattern of footprints. This shows the importance of a good and evenly applied pressure during the welding procedure. A roller with a sufficient weight should be the solution as earlier shown for joints between roofing plies [6].

According to the Swedish design regulations [8], the maximum dimension value of wind uplift can be calculated at about 3.4 kN/m². This is equal to a wind velocity of 43 m/s on a 10 m high building. Most tested roofs withstand values higher than this (Figure 6).

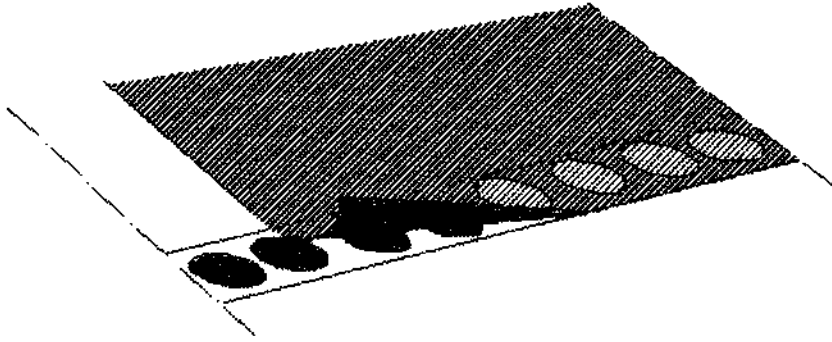
Figure 7. Footprint marks in the opened joint between the metal sheet flashing and the membrane.

When the materials, during welding, were pressed together in an uneven way, the joint contained weak regions. It seems possible that the breakage by peeling was much influenced by these weak regions.

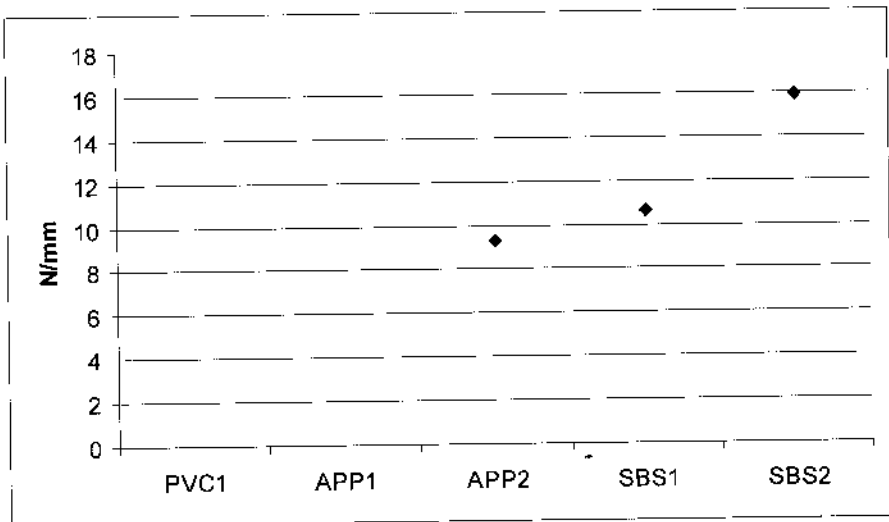
In the small scale-tests, the samples were stretched until rupture in the membrane or disbonding of the materials. Only in the case of APP2 the rupture occurred in the membrane, in all other tests the membrane separated from the metal sheet. The measured strengths are compiled in Figure 8.

Figure 8. Shear stress strength measured in small-scale test.

In the case of the small-scale test, where the failure of the joints was disbonding of the materials, the process had marks of peeling. When the samples were subjected to the force, the membrane was both elongated and the width was contracted. When the membrane contracted the bonding was torn apart. With the continuing contraction of the membrane the disbonding continued until the materials had separated. In the case of the APP2, the membrane was weaker than the joint, which should indicate a very strong joint.

When comparing the large-scale tests with the small-scale tests, the first obvious thing is that the strength differs a great deal between the tests. The significant lower strength of the large-scale test indicates that the process is not shearing. The contractions of the membrane present in the small-scale tests are not to be found in the large-scale tests; on the contrary, the membrane is stretched by the wind uplift. This means that the process that destroyed the joints in fact was a peeling force and not a shear force.
