HOLY HAIL!

Learn how to identify [hail damage](#) on roof systems

by [Scott J. Morrison, P.E.](#)

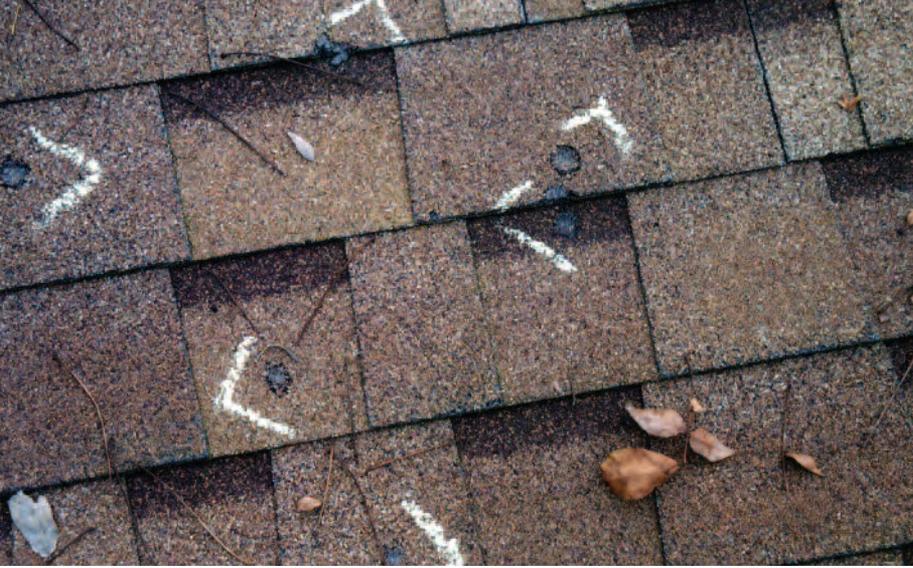
Intentionally inflicted mechanical damage to laminated asphalt shingles

Asphalt shingles, the most common steep-slope roof covering, must be punctured or fractured by hail before they are considered functionally damaged. A puncture or fracture of an asphalt shingle will leave an identifiable mark where granules are dislodged from the shingle's surface. Impact-caused fractures start on a shingle's underside (the region of maximum tensile strain) and propagate toward its topside (granule surface). Therefore, an impact-caused fracture always is detectable on a shingle's

underside. Fractures on shingles' undersides often are accompanied by fractures in shingle reinforcements, which diminish shingles' watershedding capabilities.

Some fractures can be seen on a shingle's top surface. In other instances, a fracture may not be obvious on a shingle's top surface but can be felt with your fingertips as a localized soft spot. These soft spots often are referred to as "bruises" because they feel like a bruise on an apple.

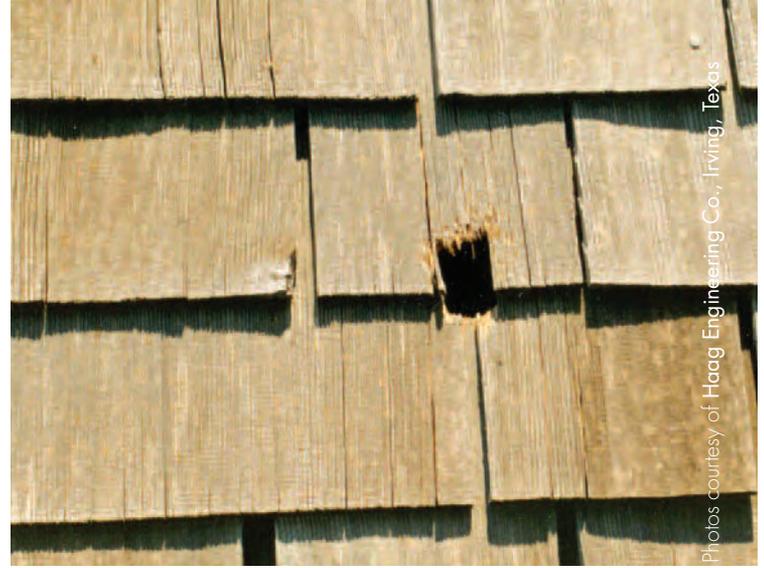
A hail-caused puncture on a wood shingle

Hail can damage wood shingles and wood shakes when it is of sufficient size, hardness and speed to reduce a shingle's or shake's watershedding capability by puncturing or splitting the wood. A hail-caused split has the following characteristics:

- The split is along the wood's grain and accompanied by a sizeable coincident dent.
- A recent split's interior is sheltered from the elements and, when opened,

reveals a bright orange color until it has had time to weather.

- The split is sharp-edged and can be made to nearly disappear when butt corners are pushed together.
- Although relatively rare, hail-caused splits can be offset from initiating dents because of support conditions that create cantilevers.

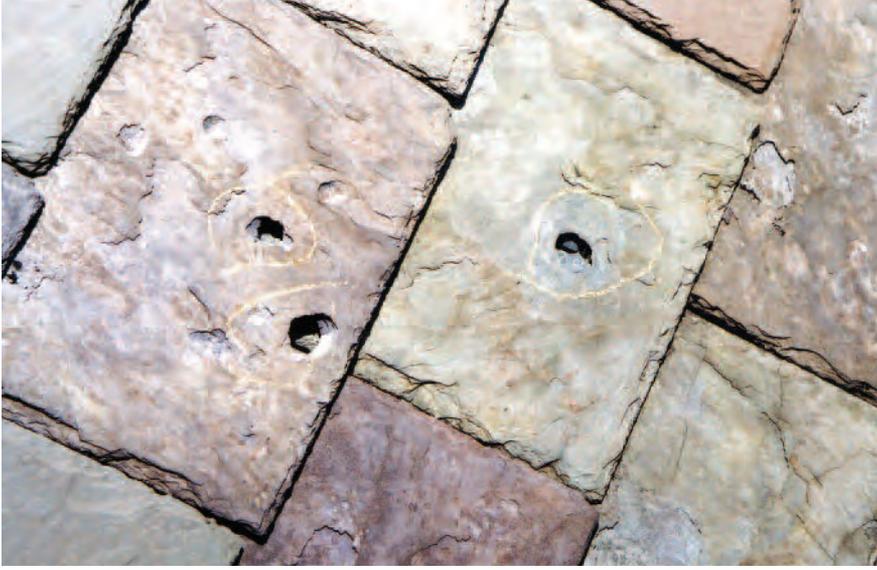
Hail-caused punctures and dents in soft slate

Slate is rigid compared with most other steep-slope roof coverings. Slate's water-shedding capabilities can be reduced when hail punctures, fractures or dents it.

Slate fractures can range from single arcs to multiple fractures radiating from a common impact point, and when substantially weathered, soft slate may simply be crushed. Areas of slate most sensitive to fractures are butt corners and edges. These can be lopped away by fractures in roughly curvilinear forms.

Fractures that expose underlayment or fasteners or create joints that are too wide or spaced too closely are considered functional damage. Near-linear fractures extending across slate usually are the result of foot traffic.

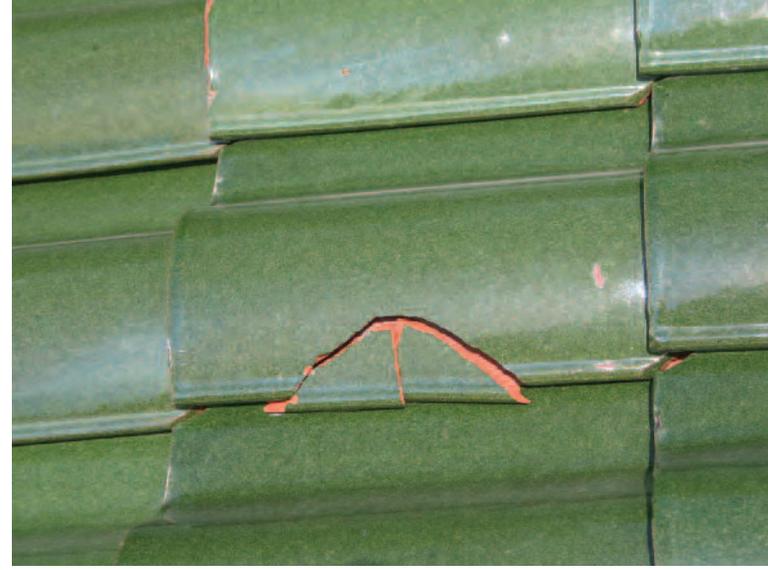
A hail-caused fracture along an overlay of a clay tile

Similar to slate, concrete and clay tiles are relatively rigid roofing materials. Tile fractures regularly are multiple fractures radiating from a common impact point.

Butt corners and overlays along edges are tiles' most impact-sensitive areas. These can be lopped away by fractures in curvilinear patterns.

Functional damage results when fractures expose underlayment or fasteners or create joints that are too wide or spaced too closely. Fractures in linear forms typically are the result of foot traffic.
